the **play inspection** company

Annual Inspection

Upton Cricket Club

Inspection Ref: 2583562

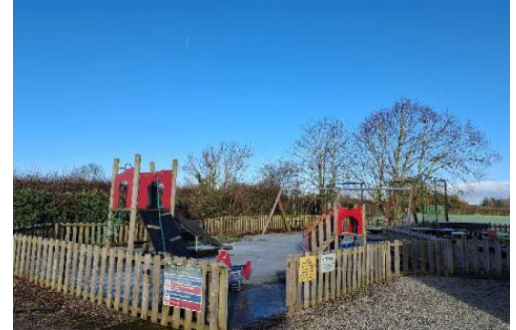
There is algae, silt or moss growth on the surface resulting in slippery conditions - Clean and treat appropriately

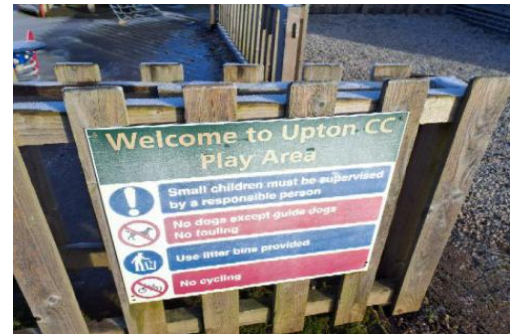
BS EN 1176 Part 7 recommends that signage shall include emergency contact details and contact details of owner / operator for reporting maintenance issues - Provide additional information

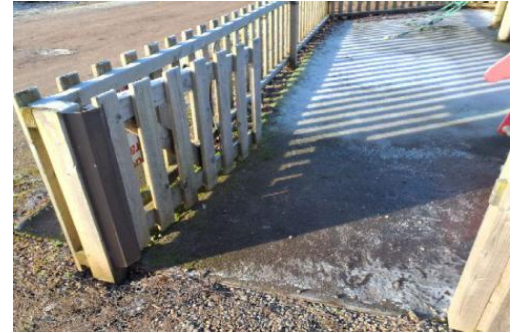
There are openings that are less than 12mm that could trap or crush fingers - Provide a 12mm gap throughout full range of motion at both sides of gate

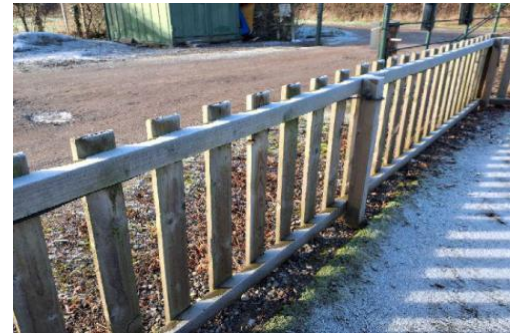
A number of fixings have worked loose around the fencing - Secure all loose fixings

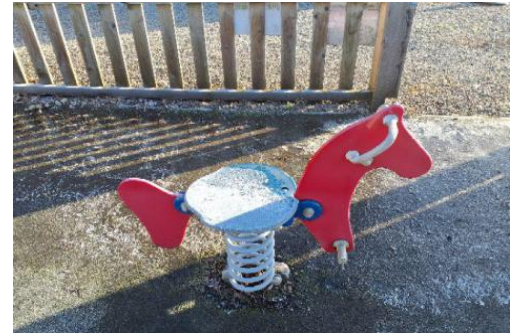
The end of handgrips and/or footrests have a cross section of less than 15cm² and fail to meet the requirements of BS EN 1176 Part 6 - Monitor - No action given the risk assessment

The entrance to the playground intersects the minimum zone of the equipment - Monitor - no remedial work recommended

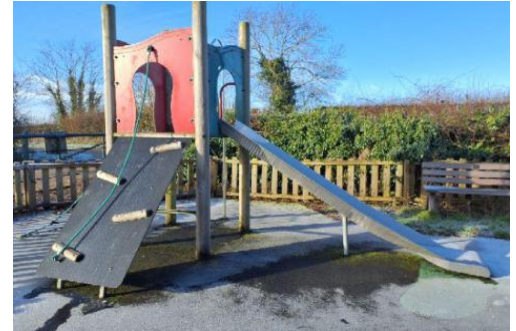
The net ferrules are corroding - Monitor for any further deterioration and replace as required

The paintwork on this item has been damaged or worn exposing the metal underneath which is rusting / corroding - Treat affected areas and repaint

There is some evidence of rot in the timber - Monitor for any further deterioration and replace as required

A number of fixing(s) have worked loose - Secure all loose fixings

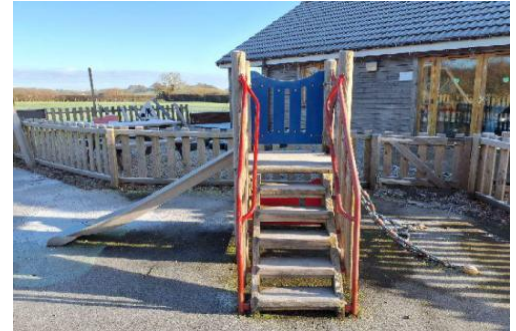
A number of fixing(s) have worked loose - Secure all loose fixings

The timber has a number of splits/shakes or air cracks and this may affect the stability or allow water ingress which will accelerate the rotting process - Monitor to ensure the splits do not cross through fixing points of the structure and/or cause any instability

The paintwork on this item has been damaged or worn exposing the metal underneath which is rusting / corroding - Treat affected areas and repaint

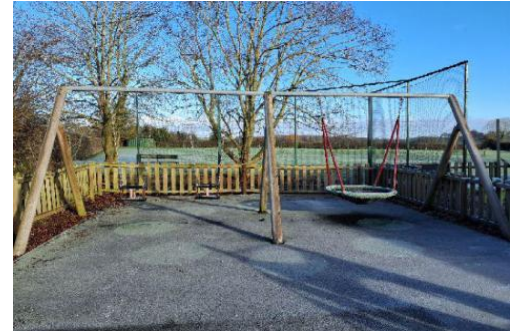
There are gaps opening between the surfacing and the edging surround or between the joints in the surfacing - Monitor for any further deterioration and repair as required

Swings of this design should have a secondary safety mechanism fitted to prevent collapse of the seat in the event of a joint failure to comply with BS EN 1176 Part 2, however this swing was installed prior to the standards being updated in 2018 and the manufacturer has confirmed that the joint was independently cycle tested by BSi - Monitor use and check the joint and fixing security regularly

The seat connection cannot be inspected fully as the chain cover cannot be lifted - Cut the cover to allow access to the shackle and assess the wear

There is some wear to the shackles. - Monitor for any further deterioration and replace when 40% worn

The surface has subsided in some areas - Monitor for any further deterioration and repair as required

The seat has minor damage or wear - Monitor for any further deterioration and replace as required

The bush / bushes is / are showing signs of wear - Monitor for any further deterioration and replace as required

BS EN 1176 requires an additional 0.5m of unobstructed space at each end of the swing surfacing area. This is a relatively low risk finding and no remedial action is recommended at this point. - Monitor - No action given the risk assessment

There is some evidence of rot in the timber posts at ground level - Monitor for any further deterioration and replace as required

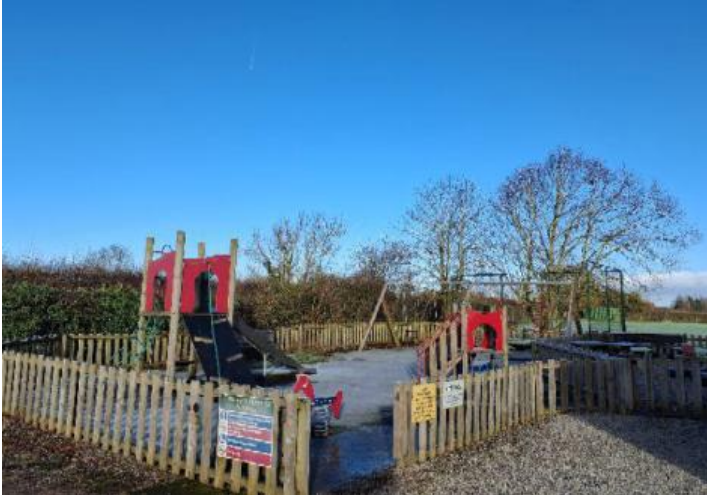
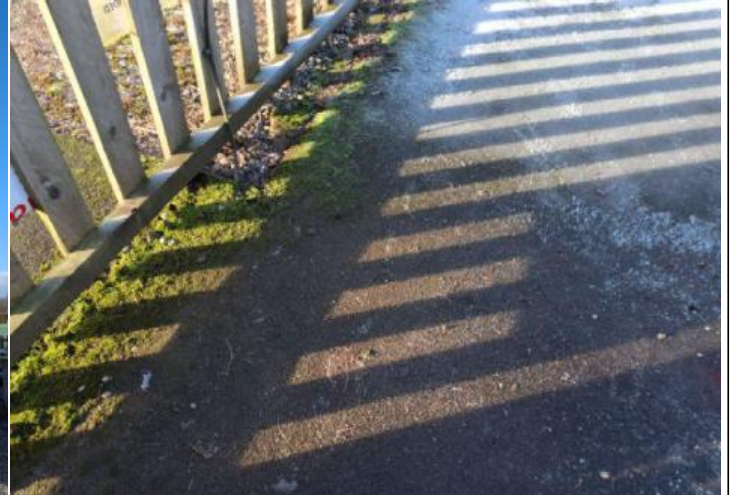
Finding: There is algae, silt or moss growth on the surface resulting in slippery conditions
Action: Clean and treat appropriately

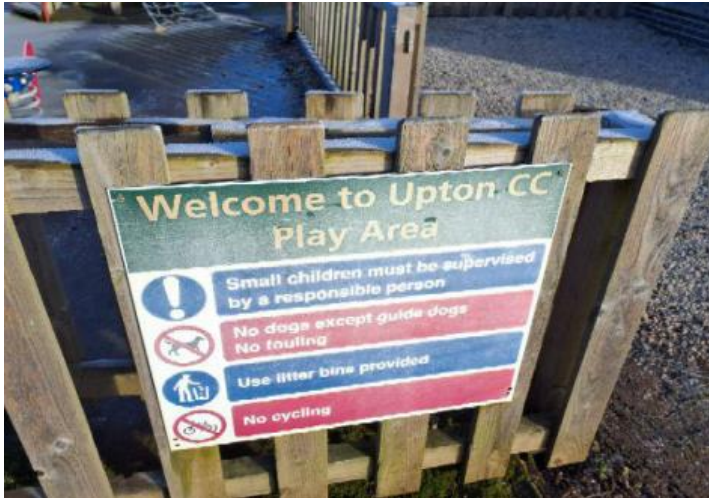
Finding: BS EN 1176 Part 7 recommends that signage shall include emergency contact details and contact details of owner / operator for reporting maintenance issues
Action: Provide additional information

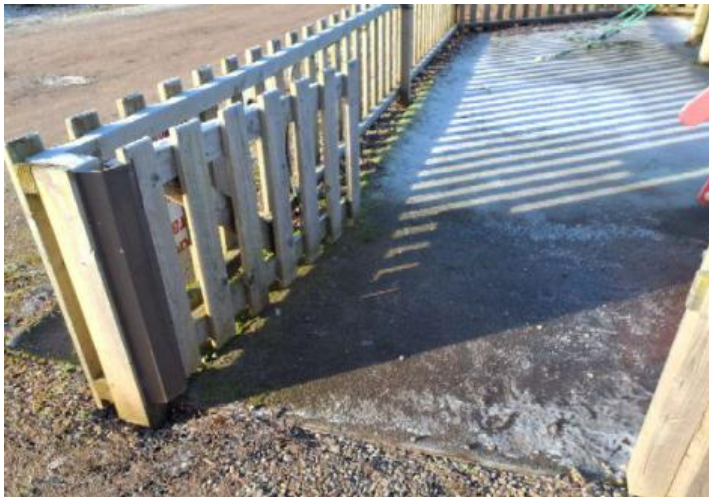
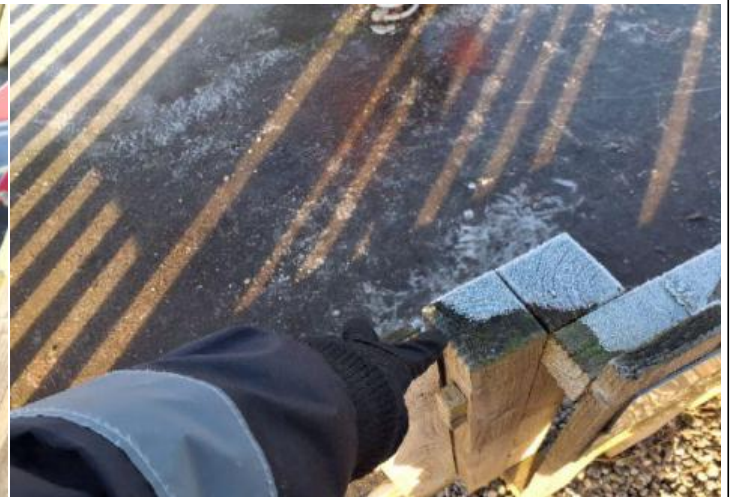
Finding: There are openings that are less than 12mm that could trap or crush fingers

Action: Provide a 12mm gap throughout full range of motion at both sides of gate

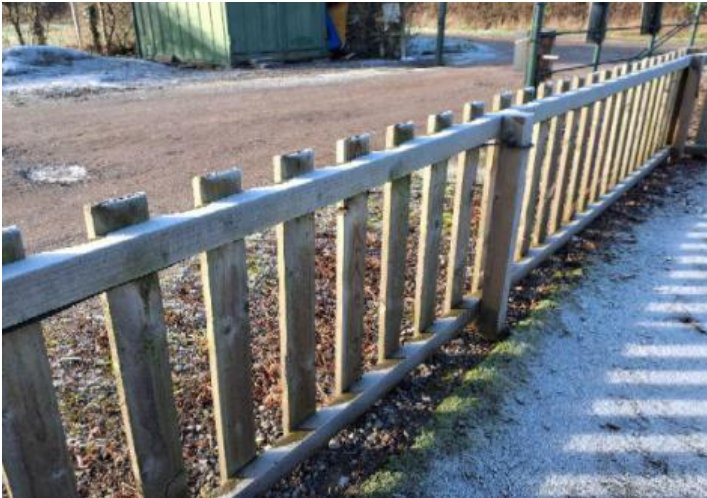
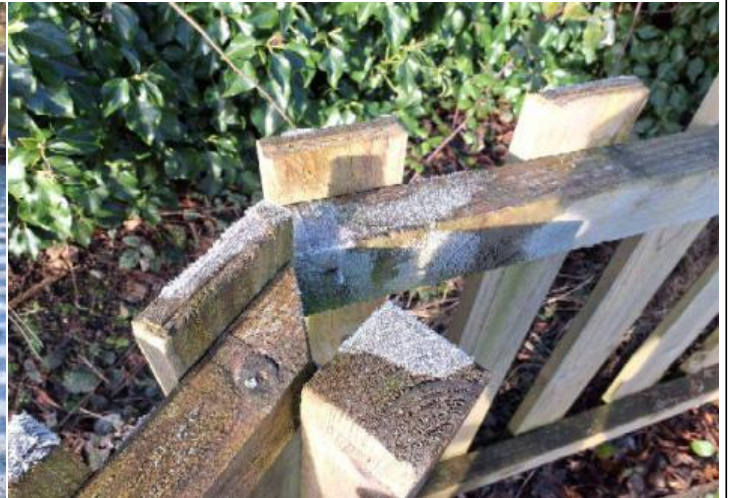
Finding: A number of fixings have worked loose around the fencing
Action: Secure all loose fixings

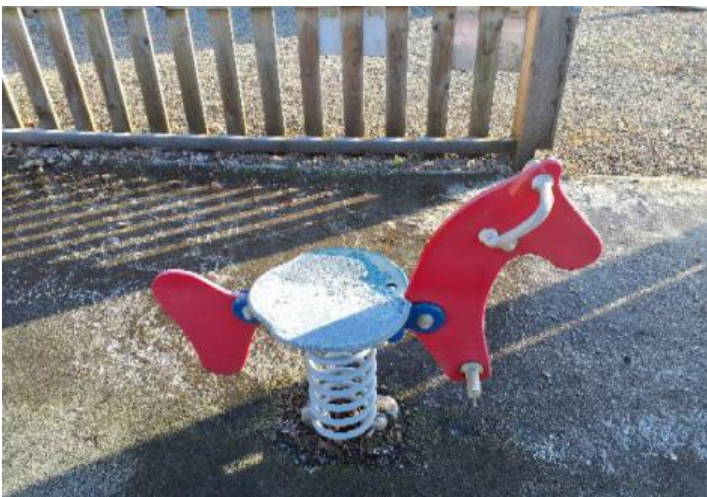
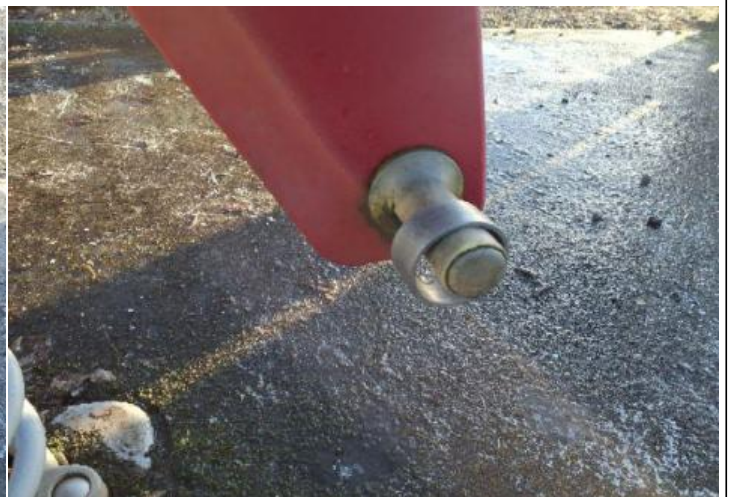
Finding: The end of handgrips and/or footrests have a cross section of less than 15cm² and fail to meet the requirements of BS EN 1176 Part 6
Action: Monitor - No action given the risk assessment

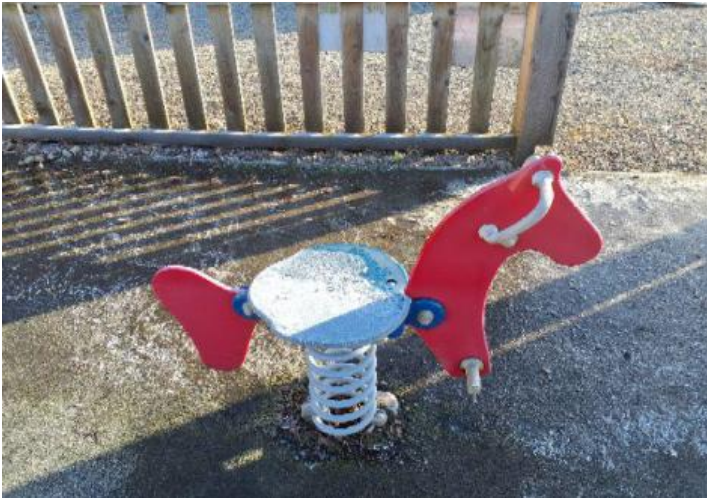
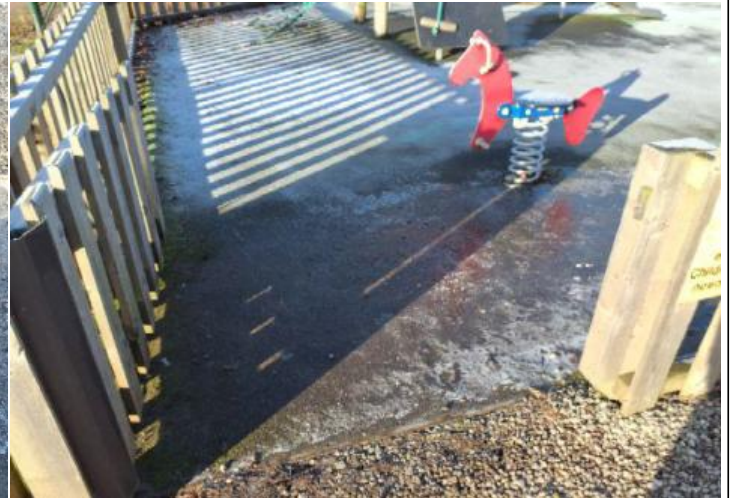
Finding: The entrance to the playground intersects the minimum zone of the equipment

Action: Monitor - no remedial work recommended

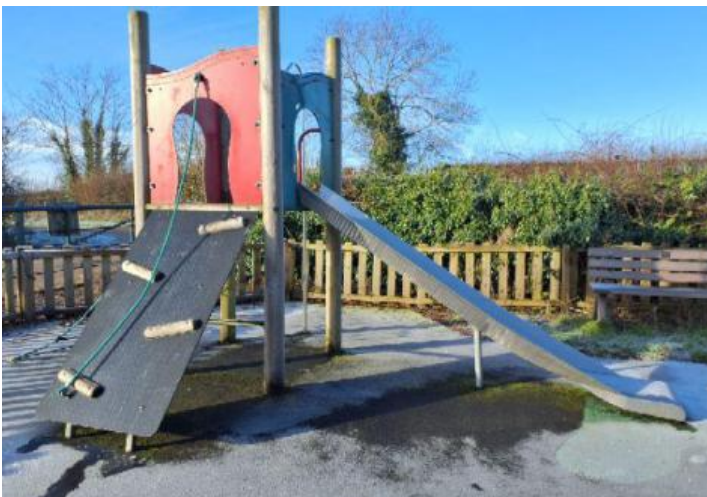
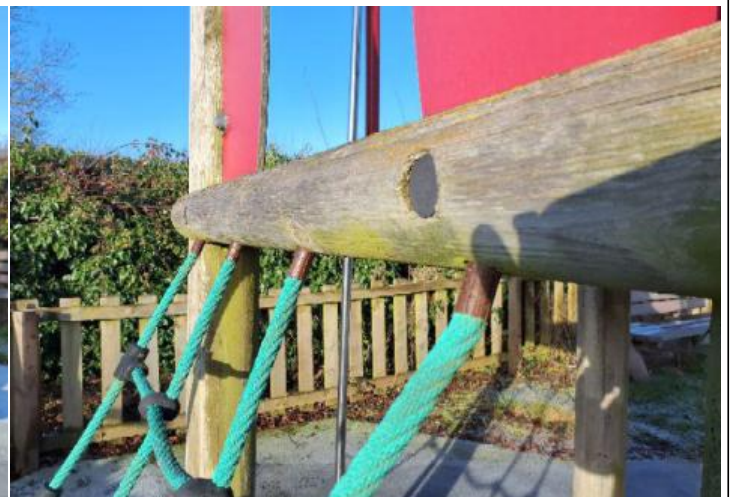
Finding: The net ferrules are corroding

Action: Monitor for any further deterioration and replace as required

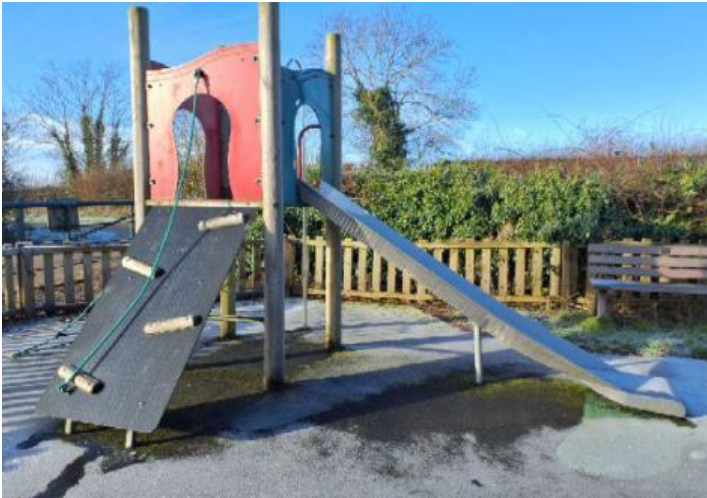
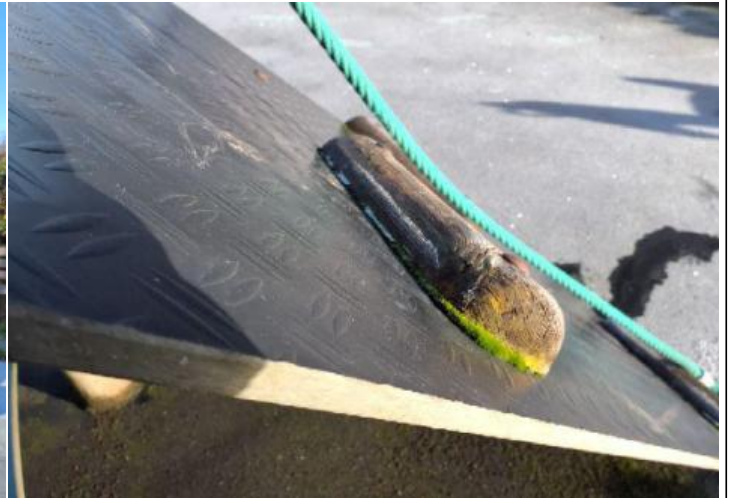
Finding: There is algae or moss on the surface of the equipment

Action: Clean and treat appropriately

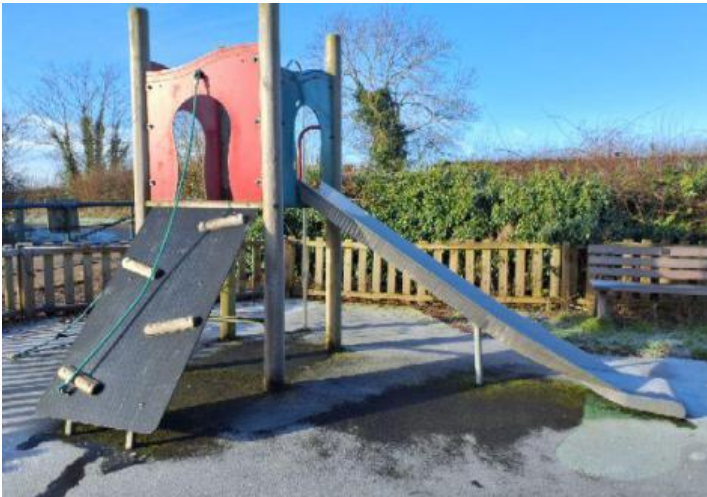
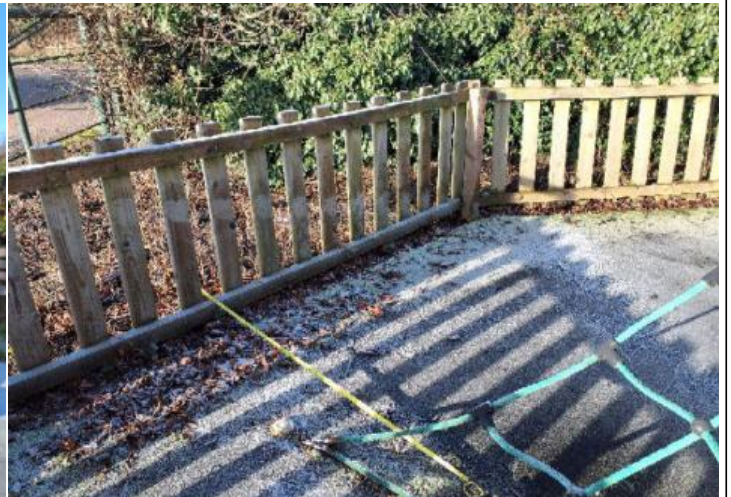
Finding: The fence forms a hard object within the falling space of the equipment and there is also insufficient surfacing provided in contravention of BS EN 1176 Part 1

Action: Monitor - No action given the risk assessment

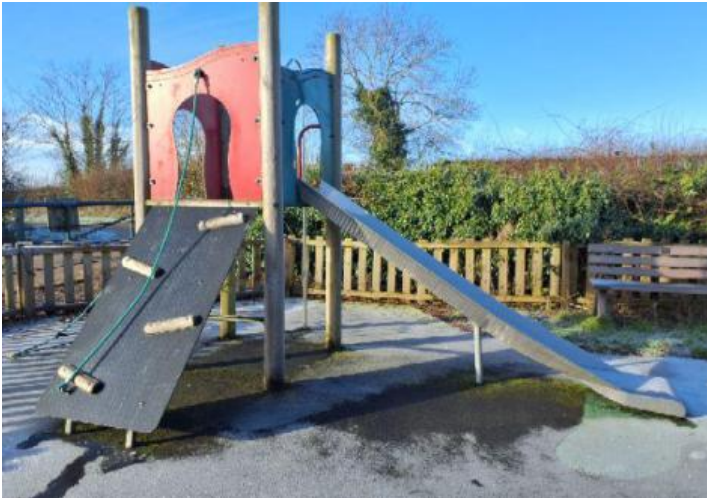
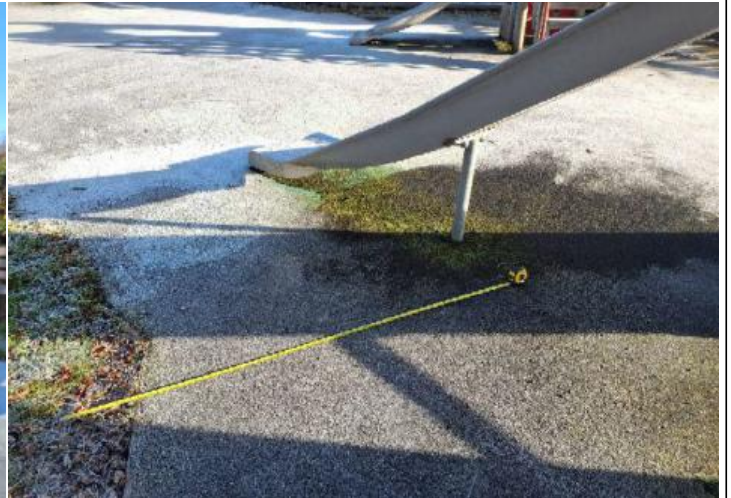
Finding: The surfacing dimensions are short and do not meet with the requirements of the current applicable standard

Action: Monitor - No action given the risk assessment

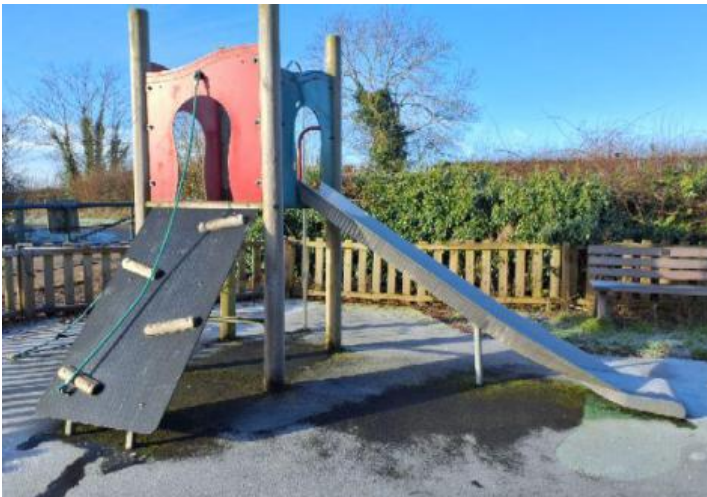
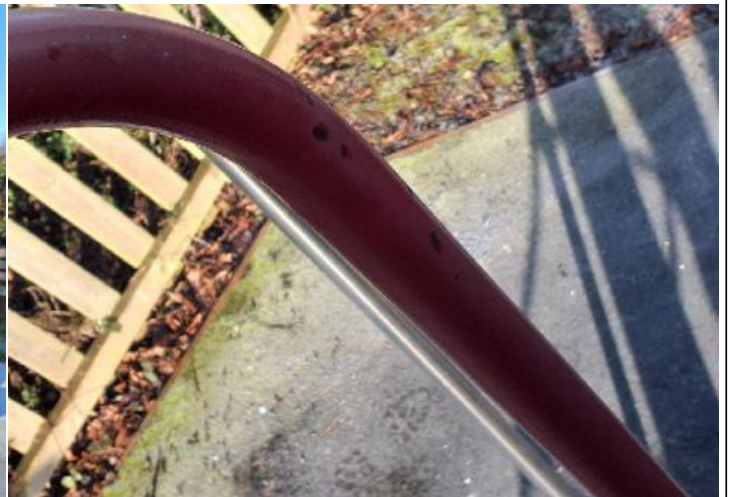
Finding: The paintwork on this item has been damaged or worn exposing the metal underneath which is rusting / corroding

Action: Treat affected areas and repaint

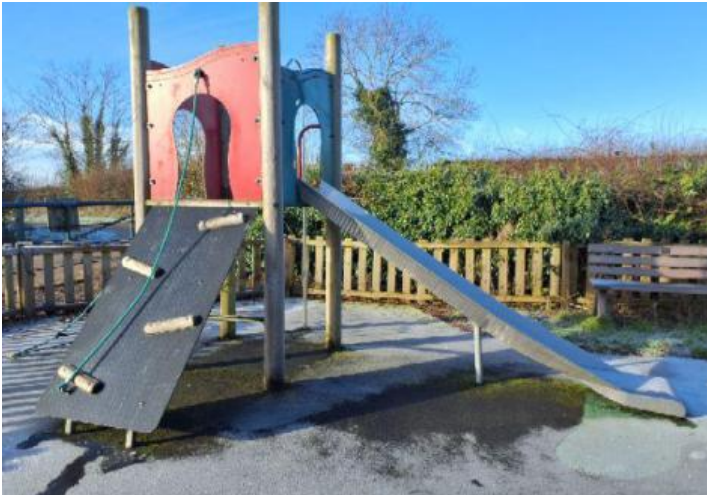
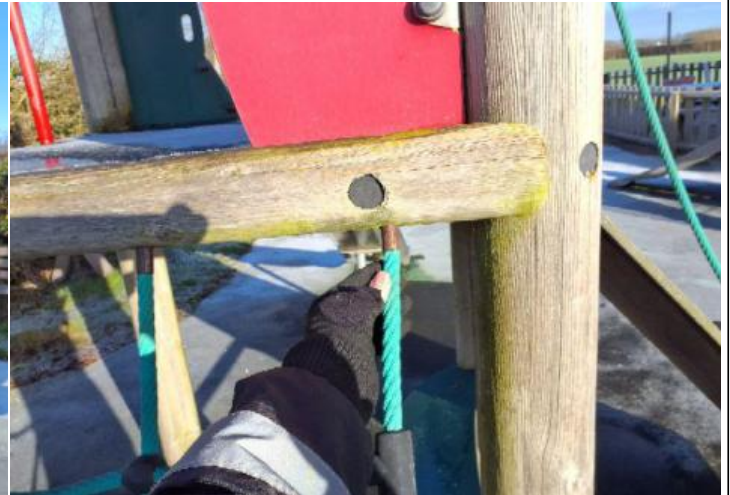
Finding: A number of fixing(s) have worked loose

Action: Secure all loose fixings

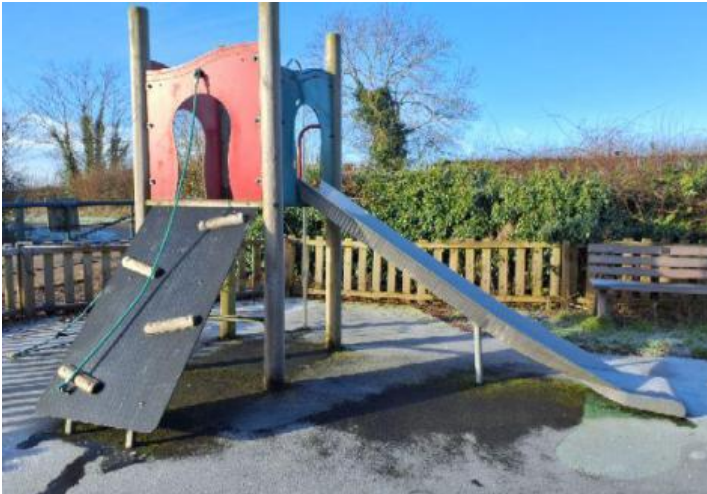
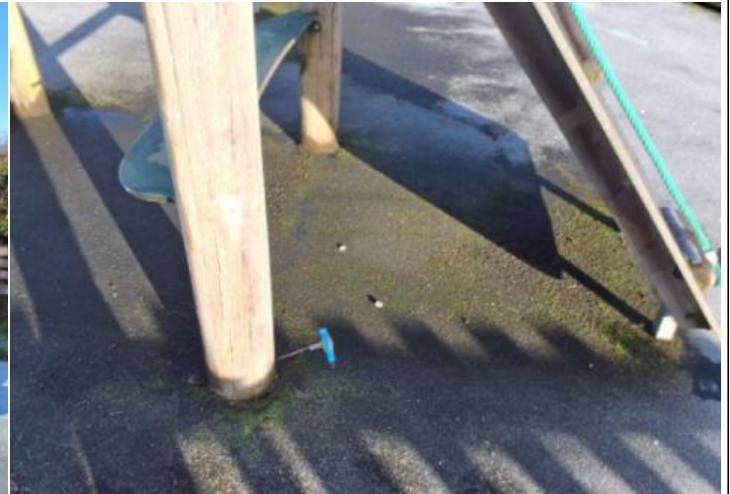
Finding: There is some evidence of rot in the timber

Action: Monitor for any further deterioration and replace as required

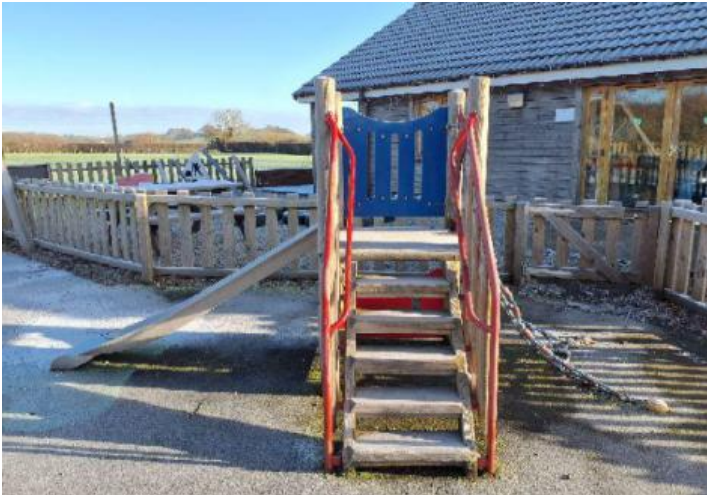
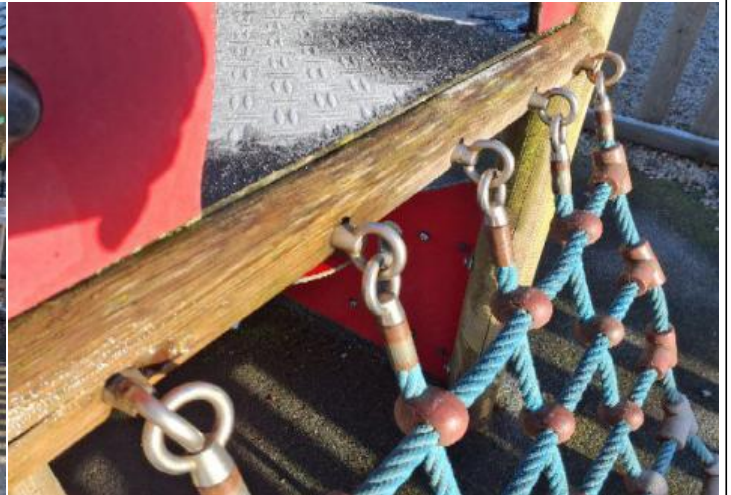
Finding: A number of fixing(s) have worked loose

Action: Secure all loose fixings

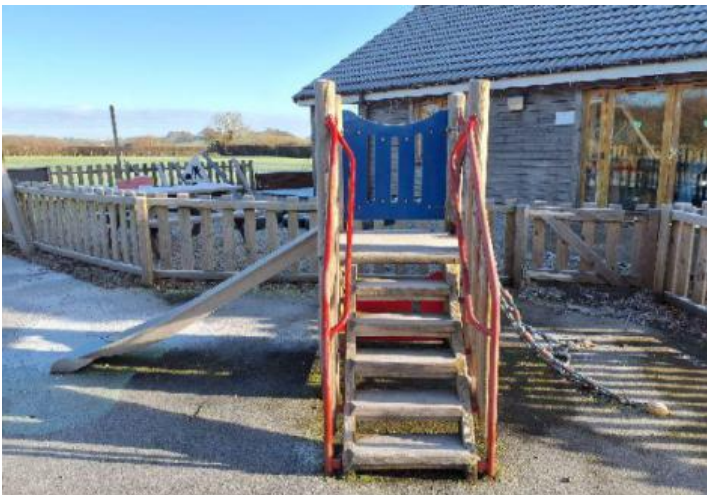
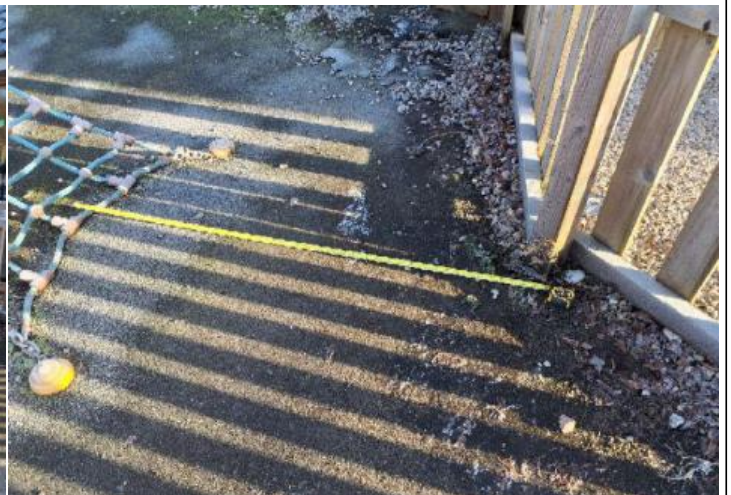
Finding: The fence forms a hard object within the falling space of the equipment and there is also insufficient surfacing provided in contravention of BS EN 1176 Part 1

Action: Monitor - No action given the risk assessment

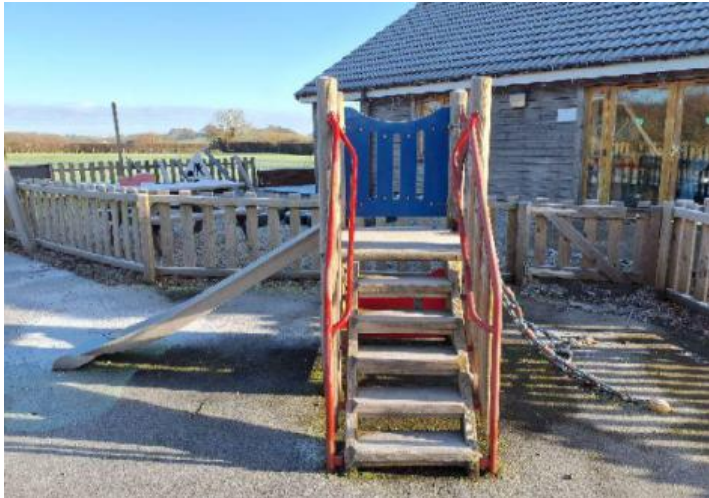
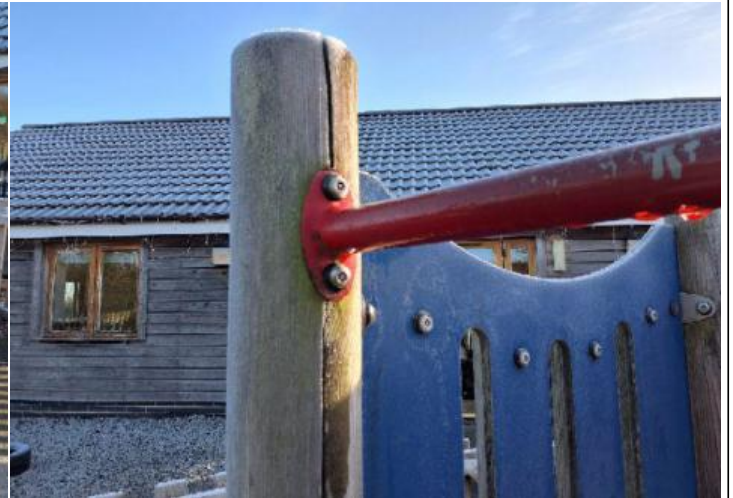
Finding: The timber has a number of splits/shakes or air cracks and this may affect the stability or allow water ingress which will accelerate the rotting process

Action: Monitor to ensure the splits do not cross through fixing points of the structure and/or cause any instability

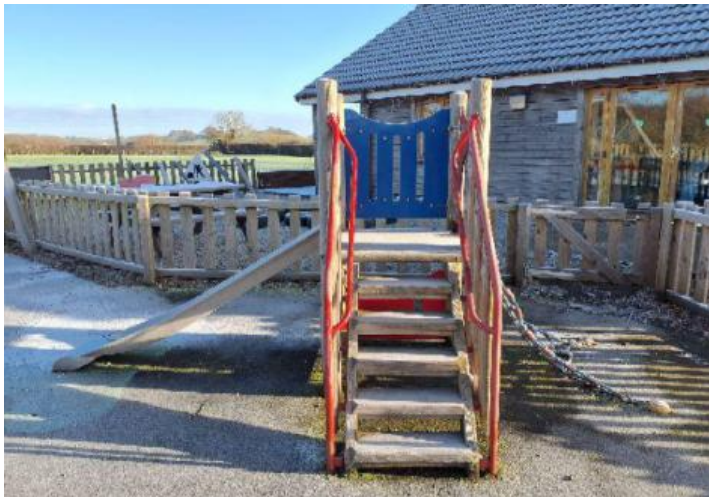
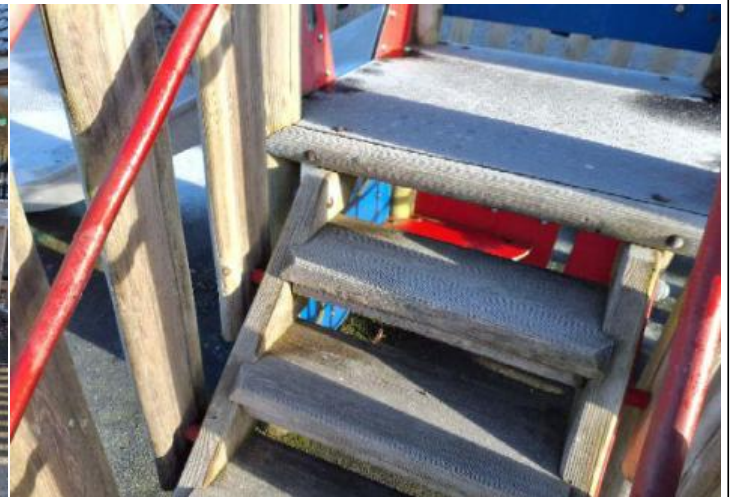
Finding: There is algae or moss on the surface of the equipment

Action: Clean and treat appropriately

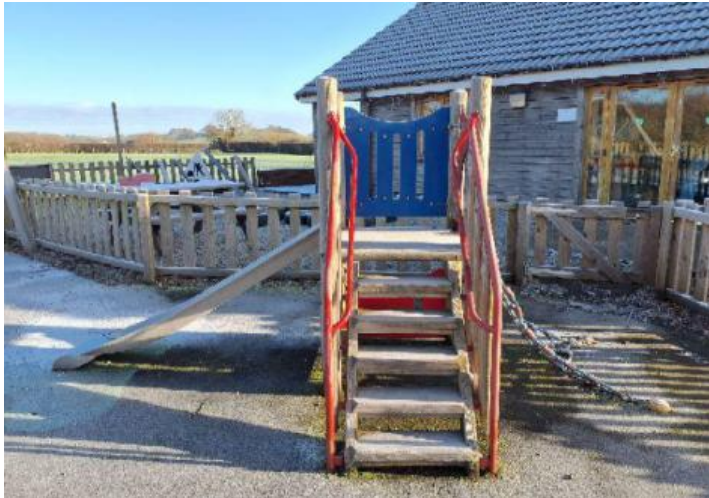
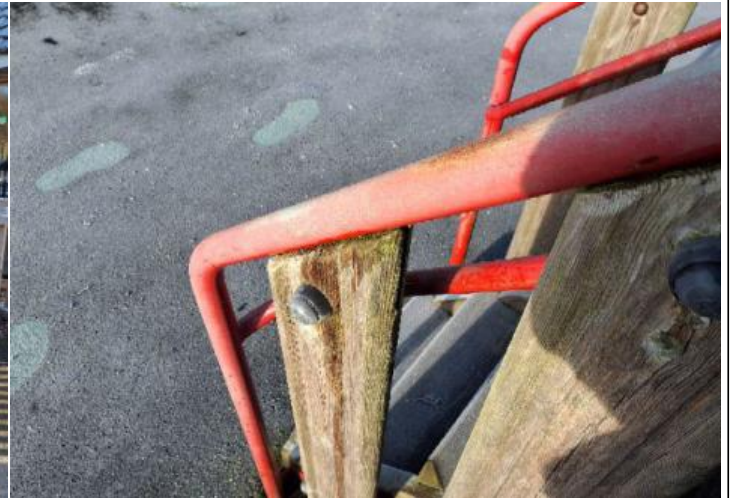
Finding: The paintwork on this item has been damaged or worn exposing the metal underneath which is rusting / corroding

Action: Treat affected areas and repaint

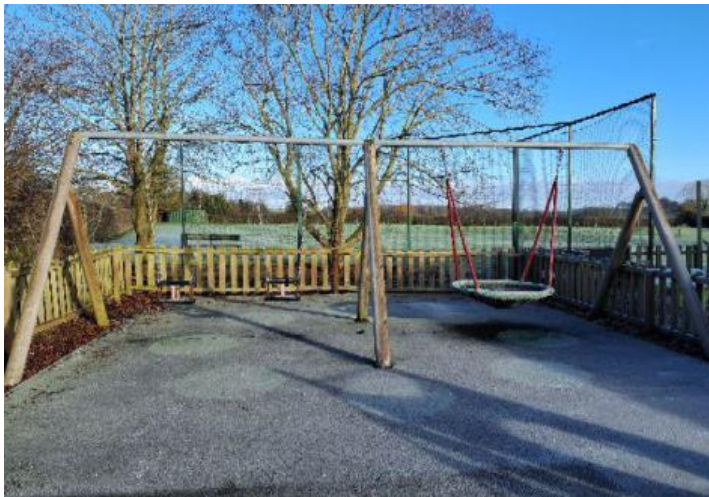
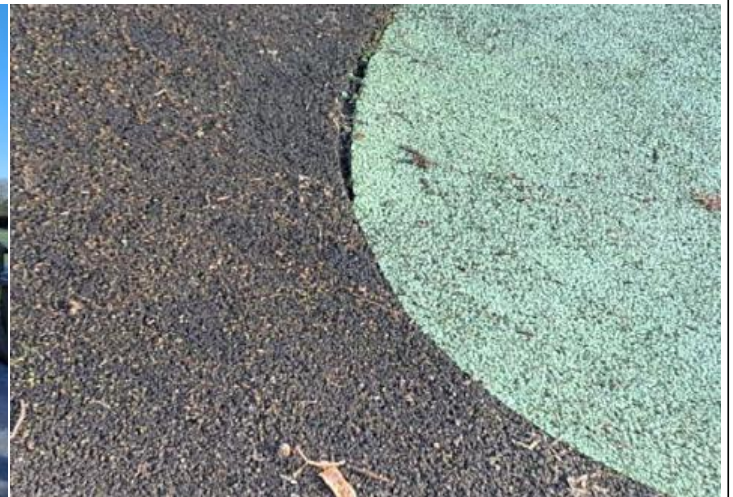
Finding: There are gaps opening between the surfacing and the edging surround or between the joints in the surfacing

Action: Monitor for any further deterioration and repair as required

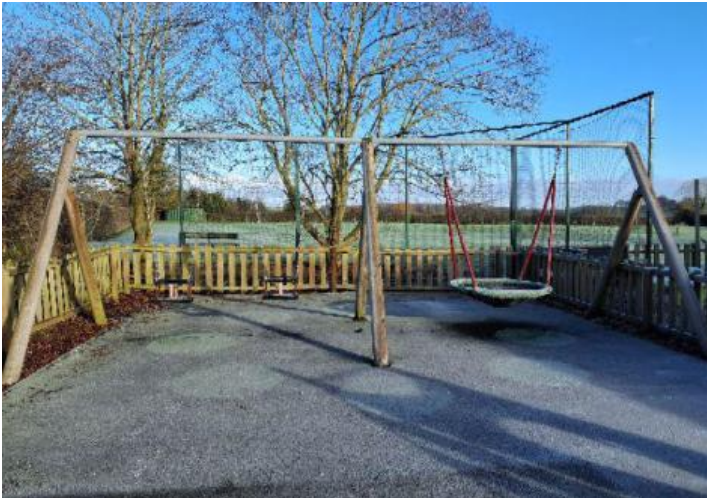
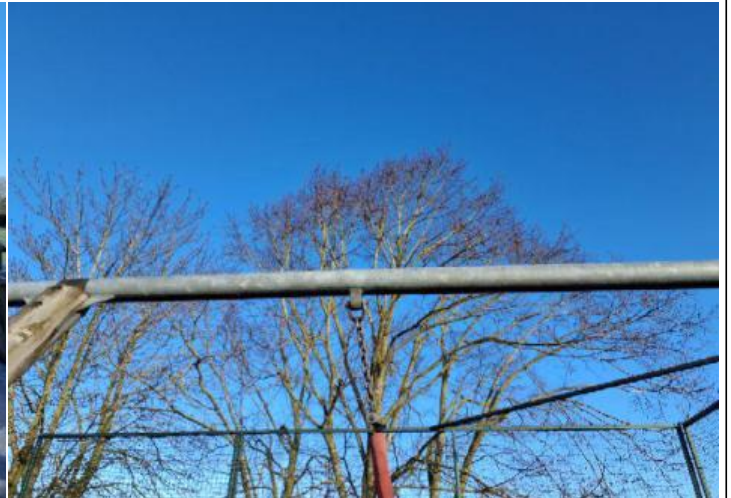
Finding: Swings of this design should have a secondary safety mechanism fitted to prevent collapse of the seat in the regularly event of a joint failure to comply with BS EN 1176 Part 2, however this swing was installed prior to the standards being updated in 2018 and the manufacturer has confirmed that the joint was independently cycle tested by BSi

Action: Monitor use and check the joint and fixing security

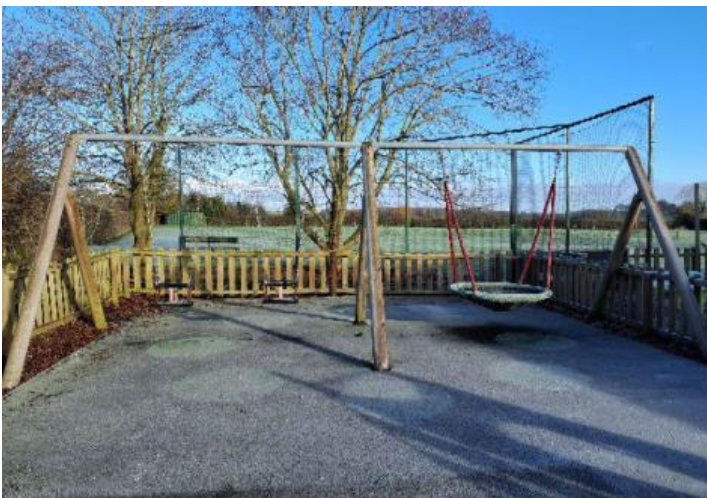
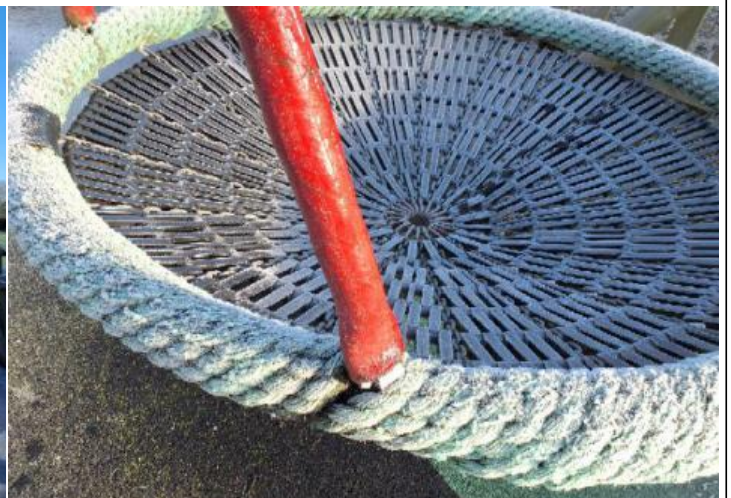
Finding: The seat connection cannot be inspected fully as the chain cover cannot be lifted

Action: Cut the cover to allow access to the shackle and assess the wear

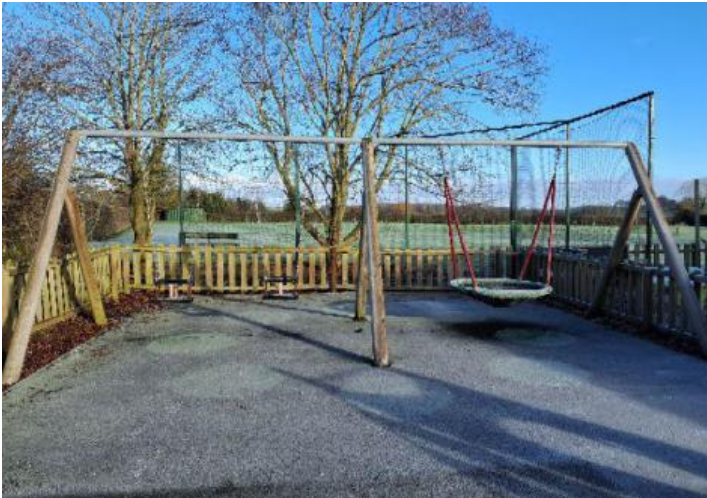
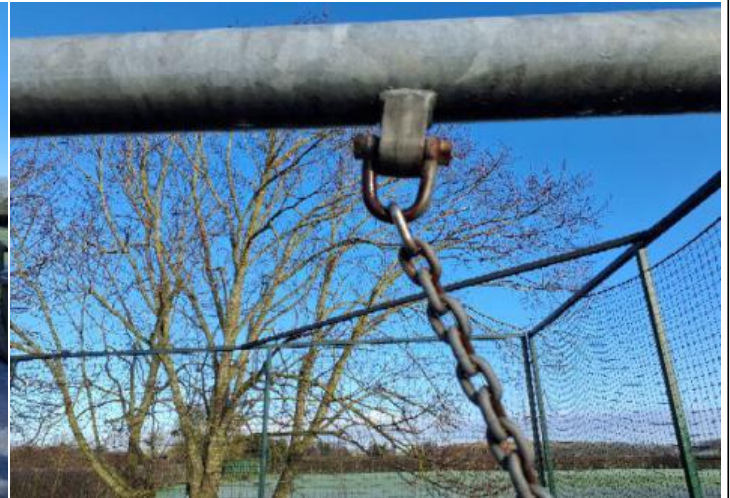
Finding: There is some wear to the shackles.

Action: Monitor for any further deterioration and replace when 40% worn

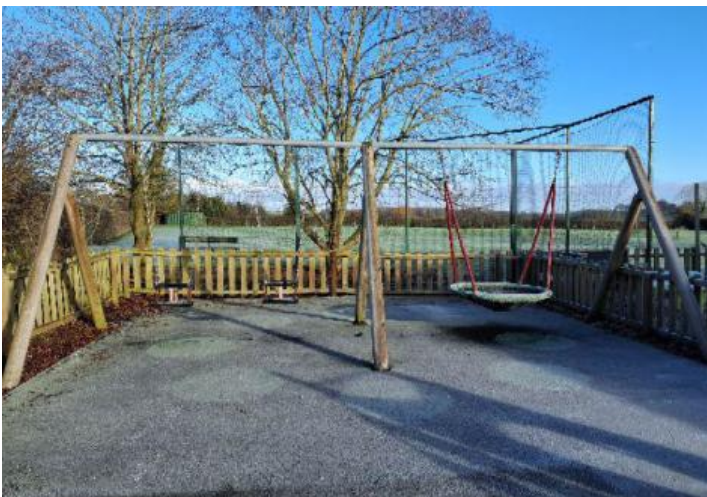
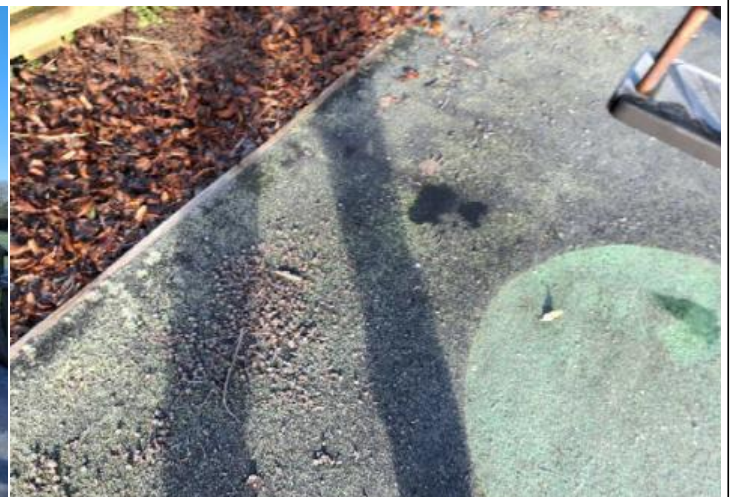
Finding: The surface has subsided in some areas

Action: Monitor for any further deterioration and repair as required

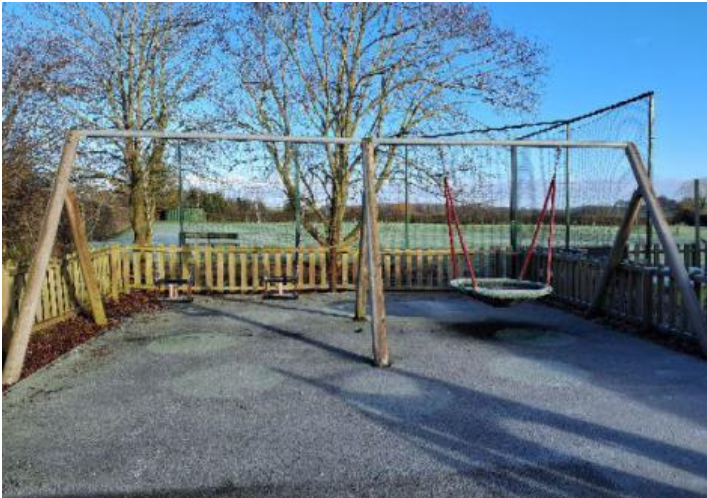
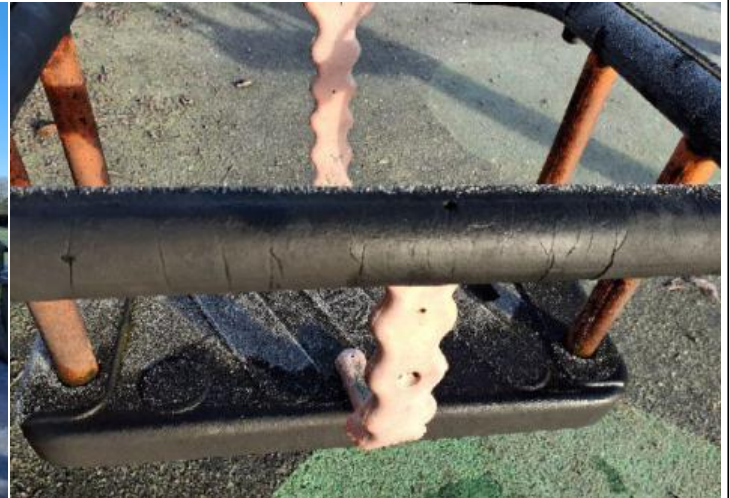
Finding: The seat has minor damage or wear

Action: Monitor for any further deterioration and replace as required

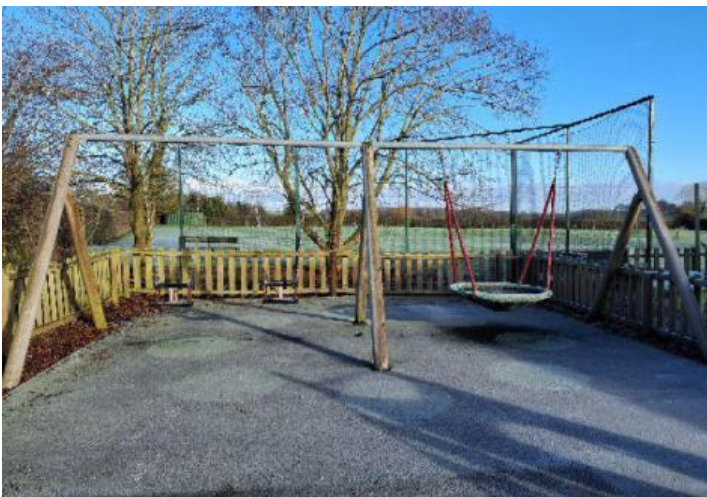
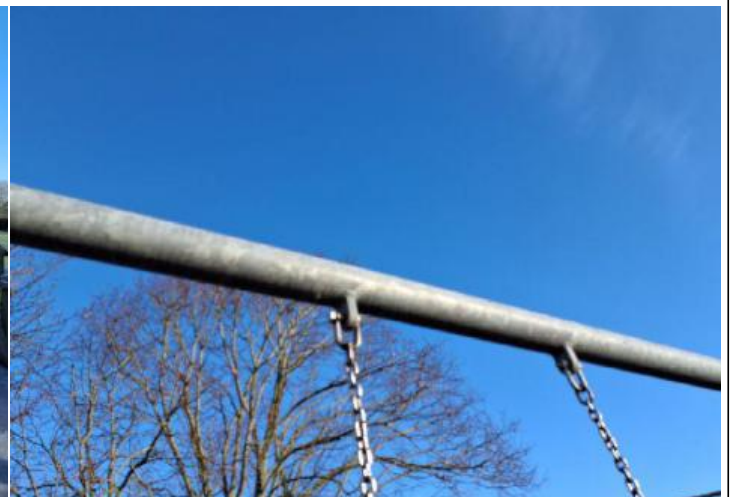
Finding: The bush / bushes is / are showing signs of wear

Action: Monitor for any further deterioration and replace as required

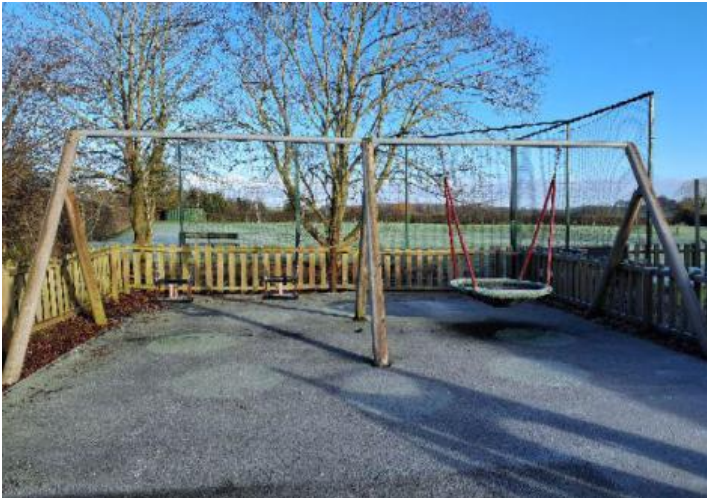
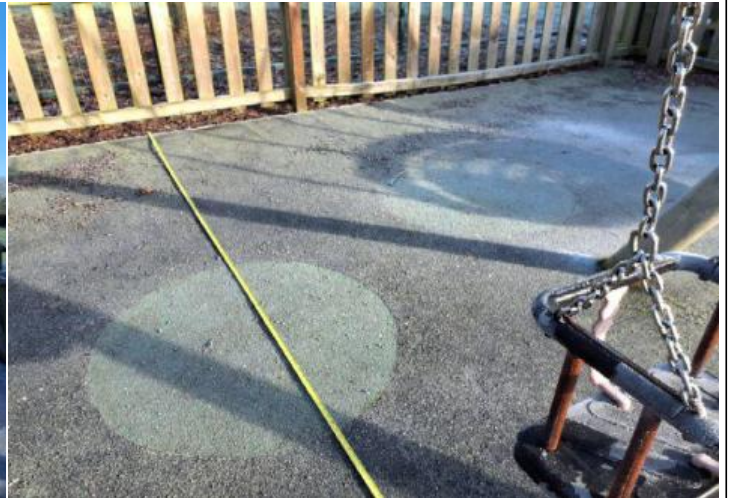
Finding: The surfacing dimensions are short and do not meet with the requirements of the current applicable standard

Action: Monitor - No action given the risk assessment

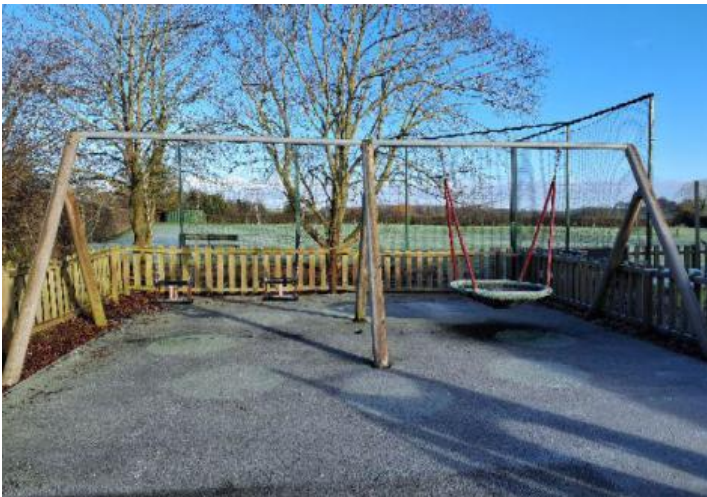
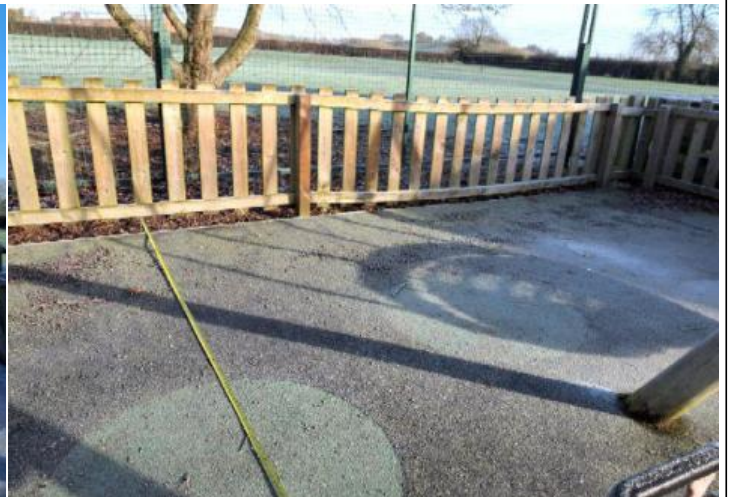
Finding: BS EN 1176 requires an additional 0.5m of unobstructed space at each end of the swing surfacing area. This is a relatively low risk finding and no remedial action is recommended at this point.

Action: Monitor - No action given the risk assessment
