the **play inspection** company

Annual Inspection

Upton Cricket Club

Inspection Ref: 2583562

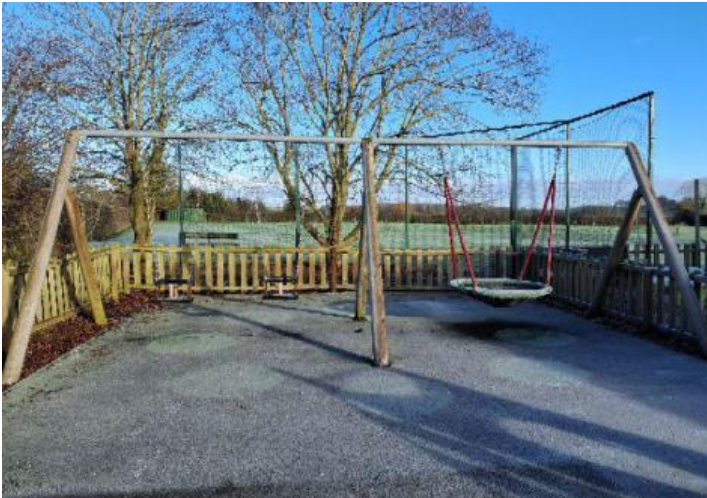
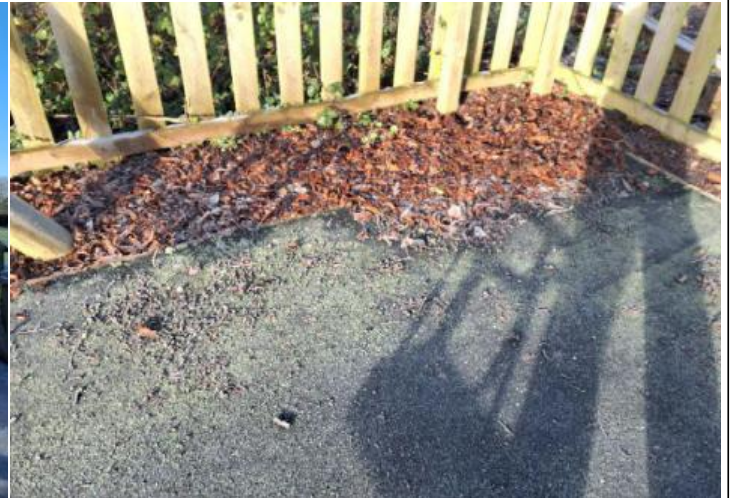
Finding: There is some tree debris on the surfacing

Action: Remove and maintain

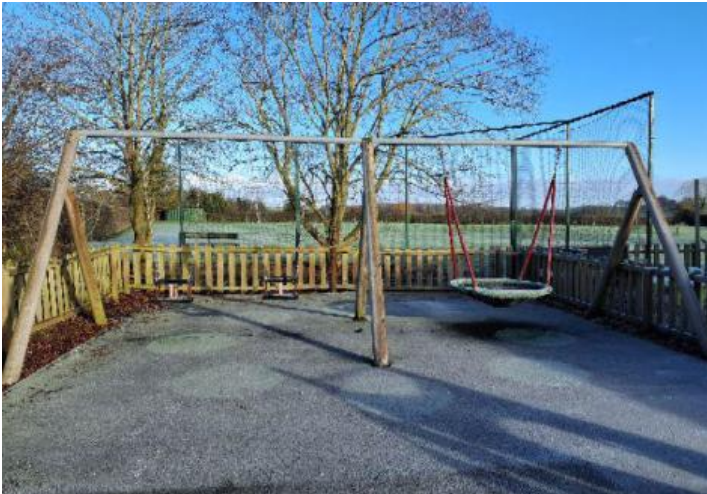
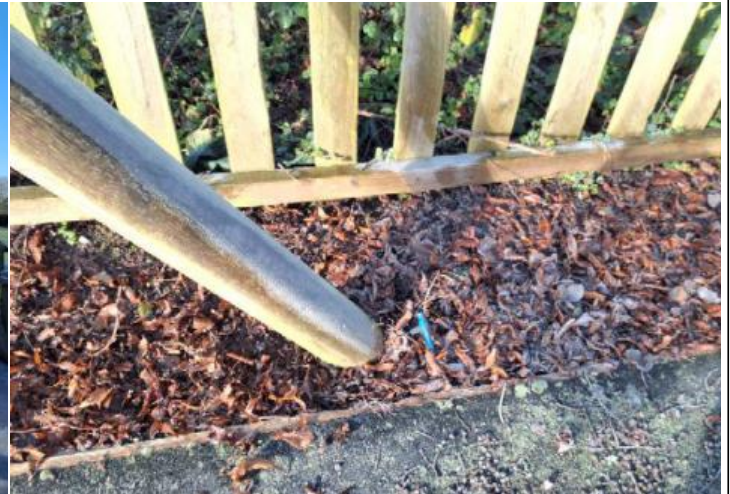
Finding: There is some evidence of rot in the timber posts at ground level

Action: Monitor for any further deterioration and replace as required
