the play inspection company

Annual Inspection

Upton Cricket Club

Inspection Ref: 1876624

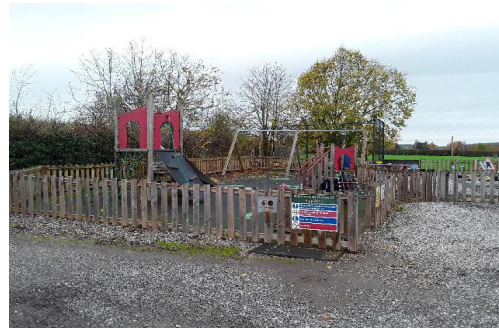
Item: Site General
Manufacturer: Owner/Operator
Surface Type: N/A
Item Quantity: 1
Equipment Compliance: N/A
Surface Area Compliance: N/A

There is algae, silt or moss growth on the surface resulting in slippery conditions - Clean and treat appropriately

There is weed / vegetation growth on, between, or around the edges of the surfacing - Remove weed / vegetation growth

There is tree debris on the surfacing - Remove and maintain

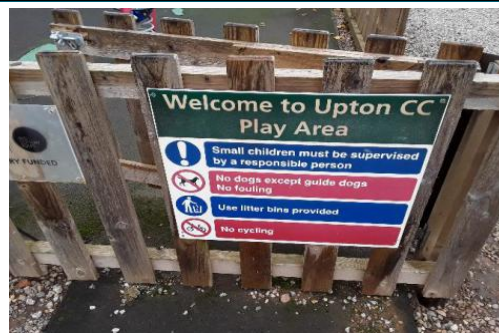
Item: Sign
Manufacturer: Owner/Operator
Surface Type: N/A
Item Quantity: 1
Equipment Compliance: N/A
Surface Area Compliance: N/A

BS EN 1176 Part 7 recommends that signage shall include emergency contact details and contact details of owner / operator for reporting maintenance issues - Provide additional information

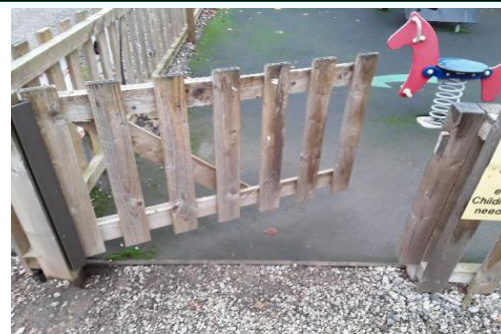
Item: Gate
Manufacturer: Owner/Operator
Surface Type: Wet Pour
Item Quantity: 2
Equipment Compliance: N/A
Surface Area Compliance: N/A

One gate was locked or secured at the time of the inspection and a full inspection could not be undertaken - Complete inspection of the gate when re-opened

The gate latch doesn't engage - Adjust the gate latch

The crush protection strip forces the gate open and the latch doesn't engage so the gate is permanently in the open position - Adjust the gate latch and consider removing the crush prevention slip (adjust the gate to remove the crush points)

There are openings that are less than 12mm that could trap or crush fingers - Where possible a 12mm gap should be maintained on both sides or between the gate leaves

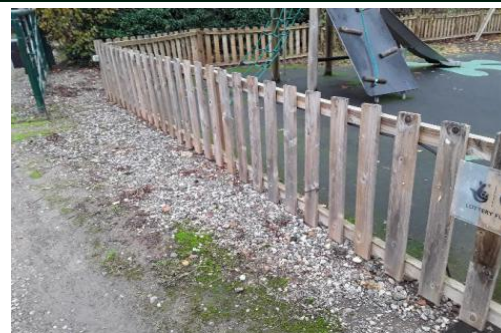
Item: Fencing - Timber
Manufacturer: Owner/Operator
Surface Type: Gravel
Item Quantity: 1
Equipment Compliance: N/A
Surface Area Compliance: N/A

Parts of the timber are rough or splintered - Remove all rough or sharp edges

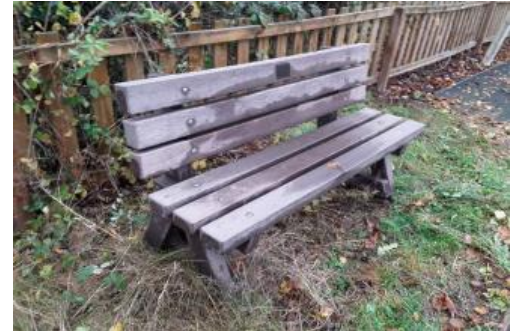
Item: Bench
Manufacturer: Owner/Operator
Surface Type: Grass
Item Quantity: 1
Equipment Compliance: N/A
Surface Area Compliance: N/A

This item is satisfactory - no work required -

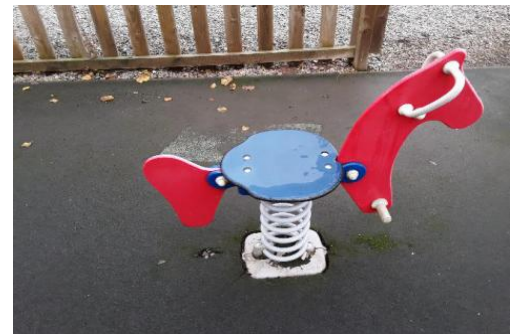
Item: Spring Horse
Manufacturer: Ledon
Surface Type: Wet Pour
Item Quantity: 1
Equipment Compliance: No
Surface Area Compliance: Yes

There is damage to the surface - Repair the damaged areas of surfacing

The end of handgrips and/or footrests have a cross section of less than 15cm² and fail to meet the requirements of BS EN 1176 Part 6 - Monitor - No remedial work recommended

The gate forms a hard object within the impact area of the equipment when in the open position - Adjust the gate

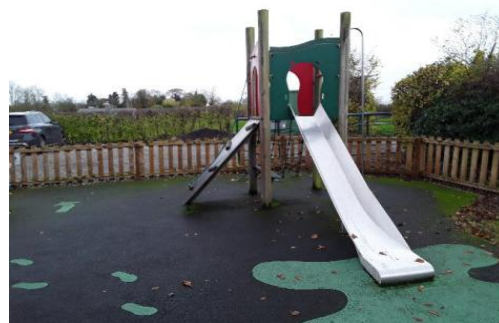
Item: Multi Play (Junior)
Manufacturer: Playdale Playgrounds Ltd
Surface Type: Wet Pour
Item Quantity: 1
Equipment Compliance: No
Surface Area Compliance: No

The fence forms a hard object within the falling space of the equipment and there is also insufficient surfacing provided in contravention of BS EN 1176 Part 1 - Monitor - no remedial work recommended

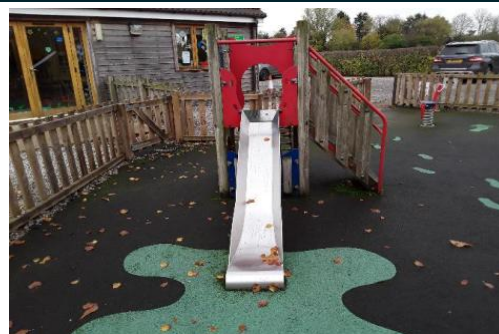
Item: Multi Play (Toddler)
Manufacturer: Playdale Playgrounds Ltd
Surface Type: Wet Pour
Item Quantity: 1
Equipment Compliance: No
Surface Area Compliance: No

The fence forms a hard object within the falling space of the equipment and there is also insufficient surfacing provided in contravention of BS EN 1176 Part 1 - Monitor - no remedial work recommended

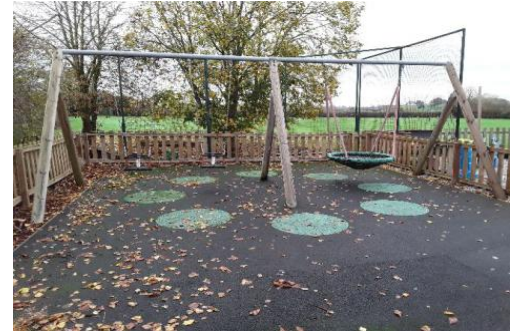
Item: 2 Bay 2 Cradle 1 Basket
Manufacturer: Playdale Playgrounds Ltd
Surface Type: Wet Pour
Item Quantity: 1
Equipment Compliance: No
Surface Area Compliance: No

The fence forms a hard object within the falling space of the equipment and there is also insufficient surfacing provided in contravention of BS EN 1176 Part 1 - Monitor - no remedial work recommended

The ropes/nets are worn/damaged in places - Monitor for any further deterioration and repair or replace as required

Swings of this design should have a secondary safety device fitted to prevent collapse of the seat in the event of a joint failure to meet the requirements of BS EN 1176 Part 2 - Consult with manufacturer and consider providing a secondary safety device where possible

The seat connection cannot be inspected fully as the chain cover cannot be lifted - Cut the cover to allow access to the shackle and assess the wear

The seat has minor damage or wear - Monitor for any further deterioration and replace as required

The chain openings are in excess of the 8.6mm as recommended by BS EN 1176 - Monitor - No remedial work recommended

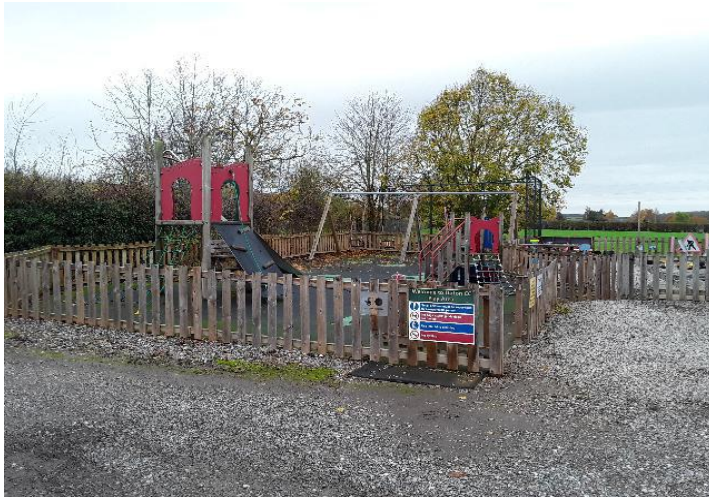
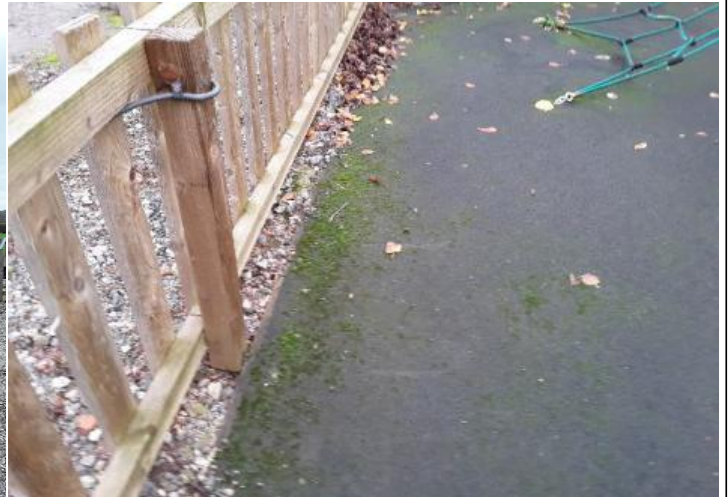
Item: Ancillary Items - Site General
Manufacturer: Owner/Operator

Finding: There is algae, silt or moss growth on the surface resulting in slippery conditions

Action: Clean and treat appropriately

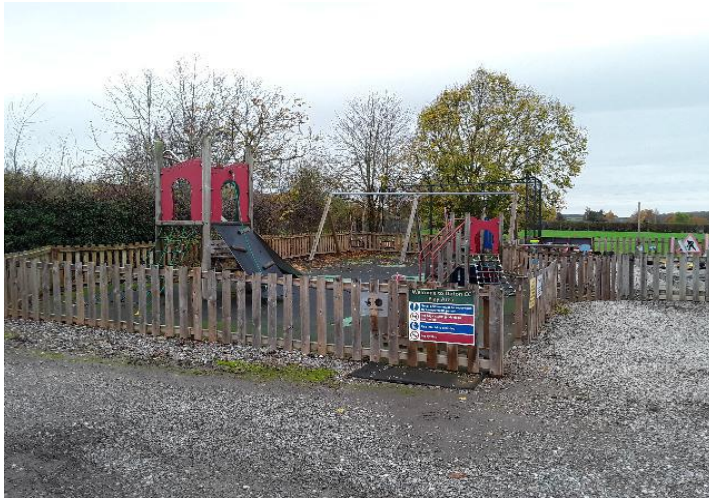
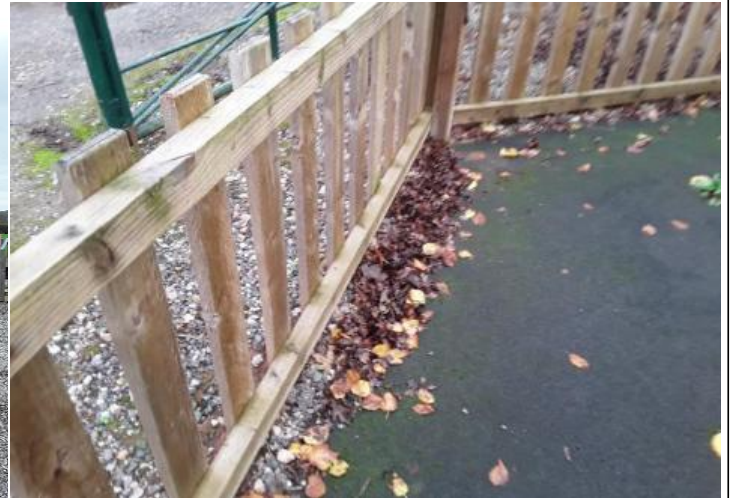
Item: Ancillary Items - Site General
Manufacturer: Owner/Operator

Finding: There is tree debris on the surfacing

Action: Remove and maintain

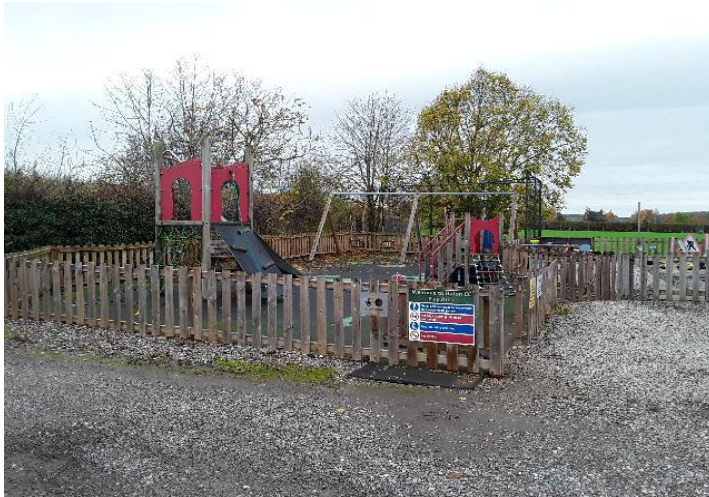
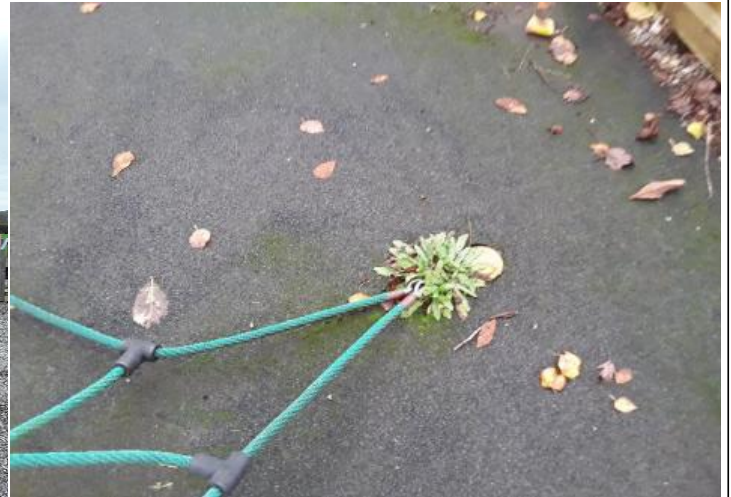
Item: Ancillary Items - Site General
Manufacturer: Owner/Operator

Finding: There is weed / vegetation growth on, between, or around the edges of the surfacing

Action: Remove weed / vegetation growth

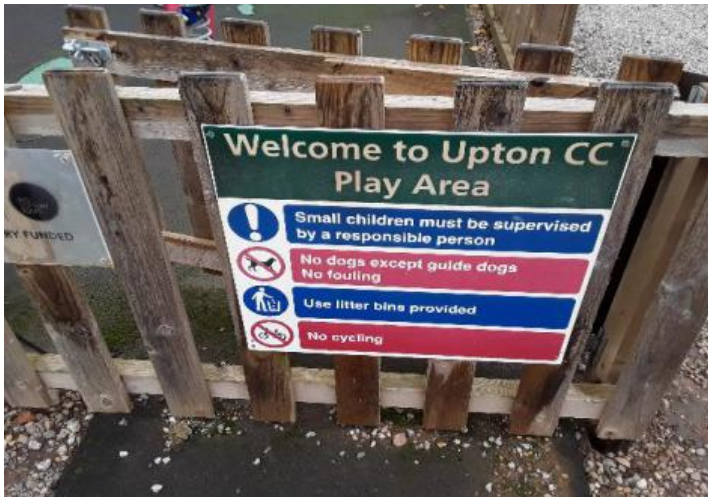
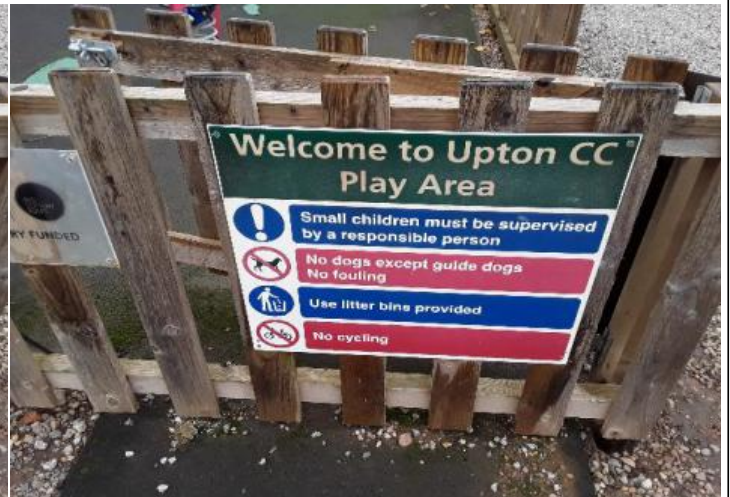
Item: Ancillary Items - Sign
Manufacturer: Owner/Operator

Finding: BS EN 1176 Part 7 recommends that signage shall include emergency contact details and contact details of owner / operator for reporting maintenance issues

Action: Provide additional information

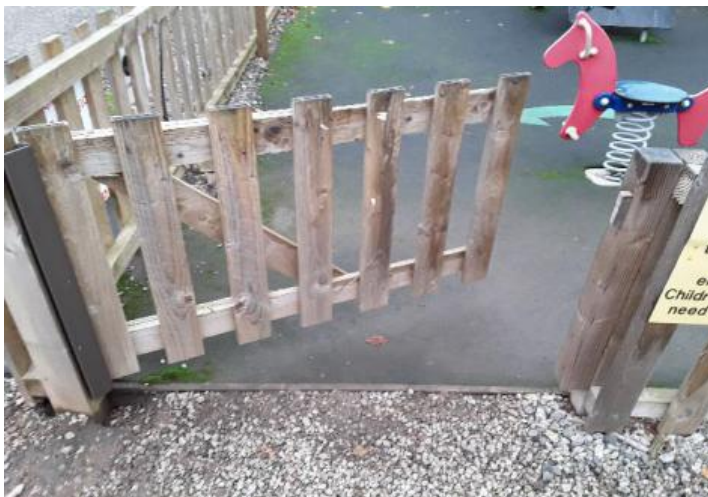
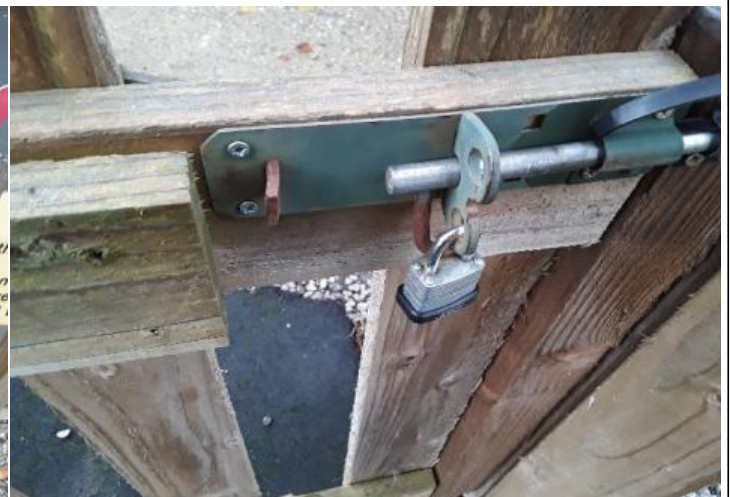
Item: Gates - Gate
Manufacturer: Owner/Operator

Finding: One gate was locked or secured at the time of the inspection and a full inspection could not be undertaken

Action: Complete inspection of the gate when re-opened

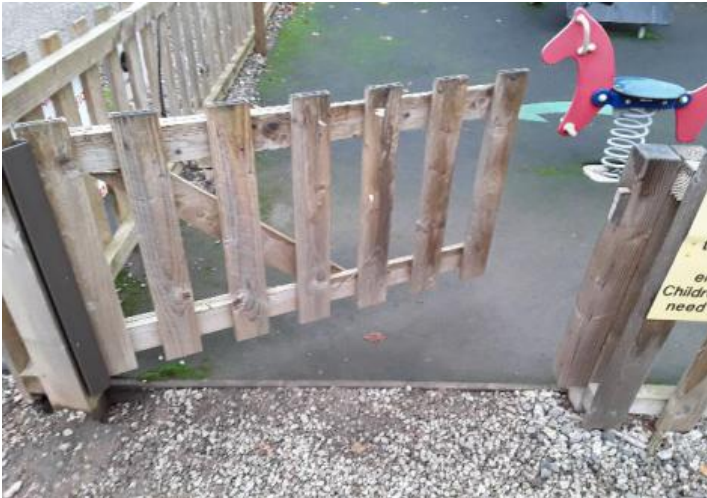
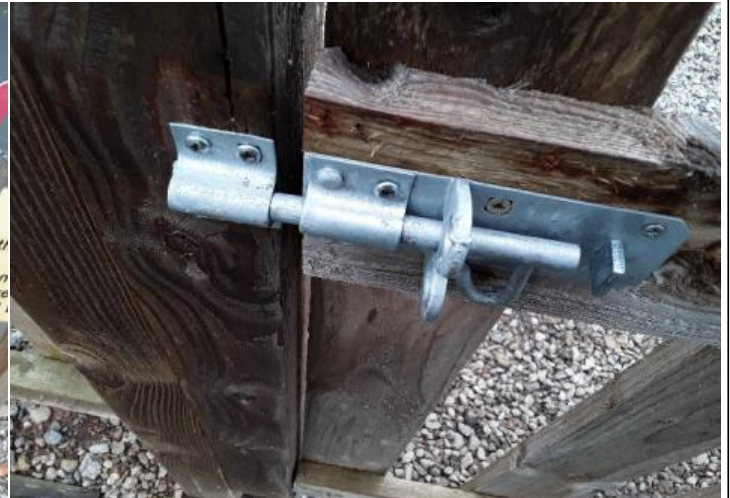
Item: Gates - Gate
Manufacturer: Owner/Operator

Finding: The gate latch doesn't engage

Action: Adjust the gate latch

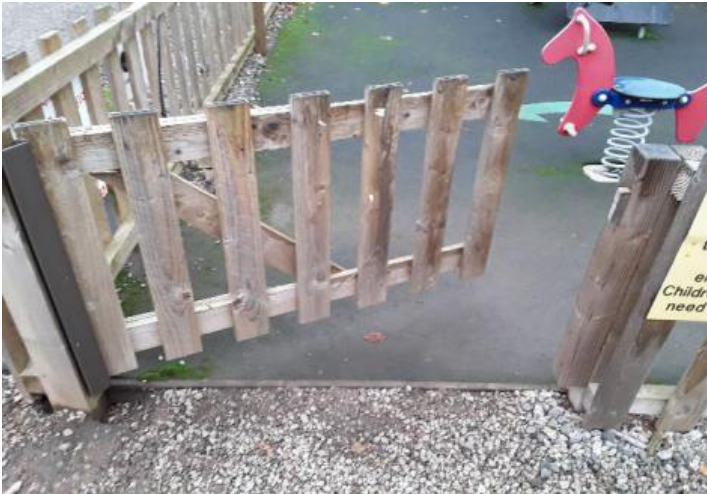
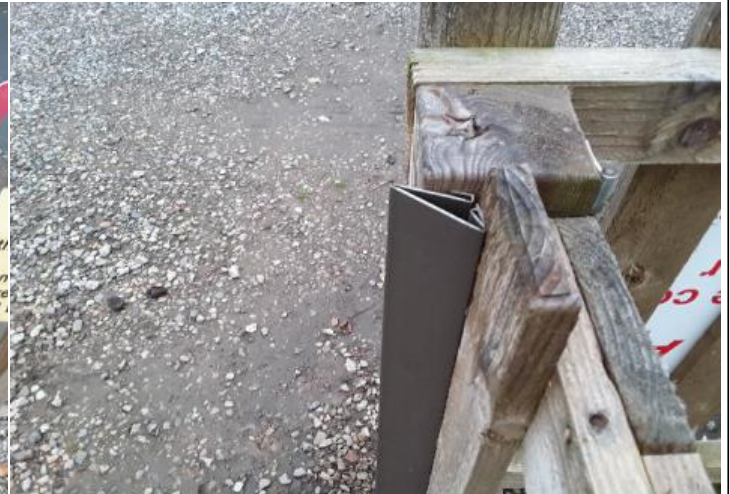
Item: Gates - Gate
Manufacturer: Owner/Operator

Finding: The crush protection strip forces the gate open and the latch doesn't engage so the gate is permanently in the open position

Action: Adjust the gate latch and consider removing the crush prevention slip (adjust the gate to remove the crush points)

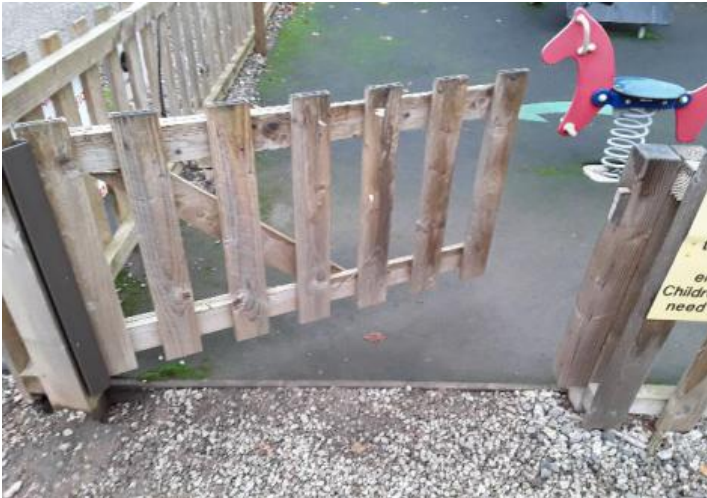
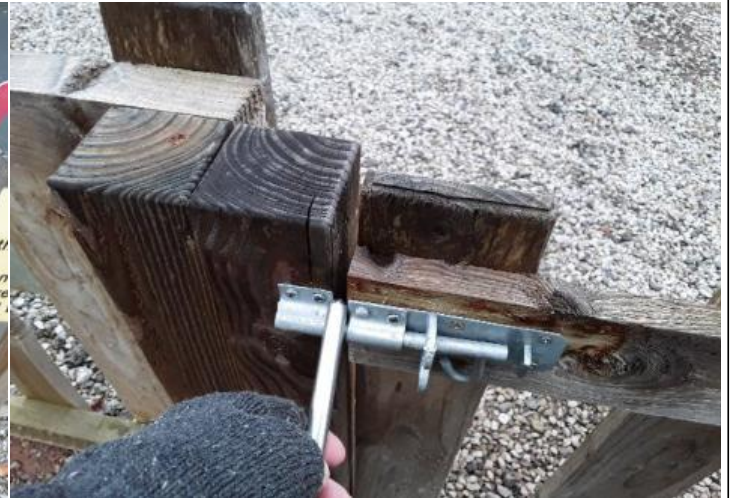
Item: Gates - Gate
Manufacturer: Owner/Operator

Finding: There are openings that are less than 12mm that could trap or crush fingers

Action: Where possible a 12mm gap should be maintained on both sides or between the gate leaves

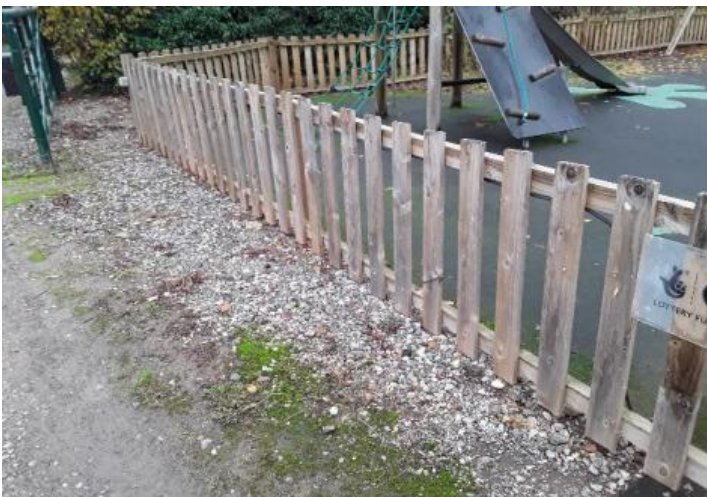
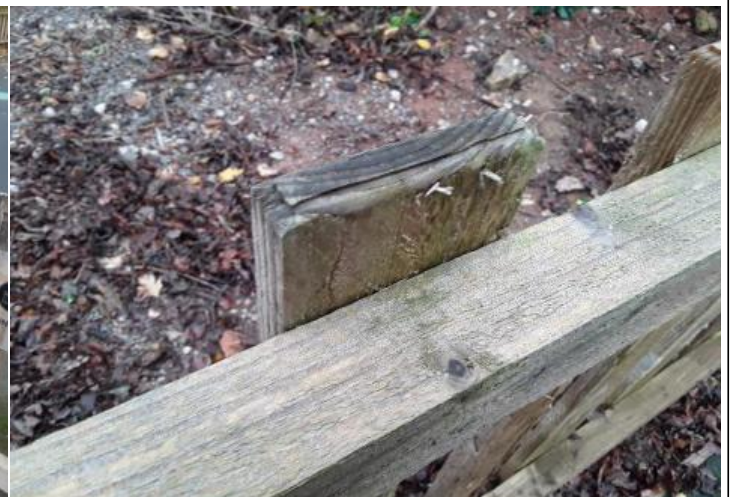
Item: Fences - Fencing - Timber
Manufacturer: Owner/Operator

Finding: Parts of the timber are rough or splintered

Action: Remove all rough or sharp edges

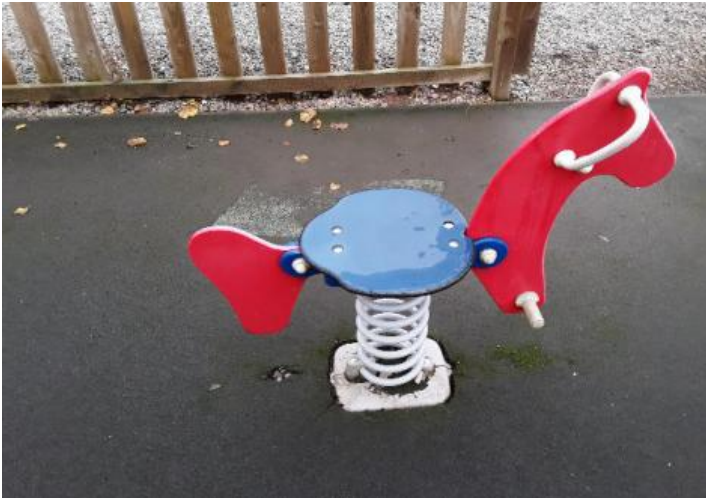
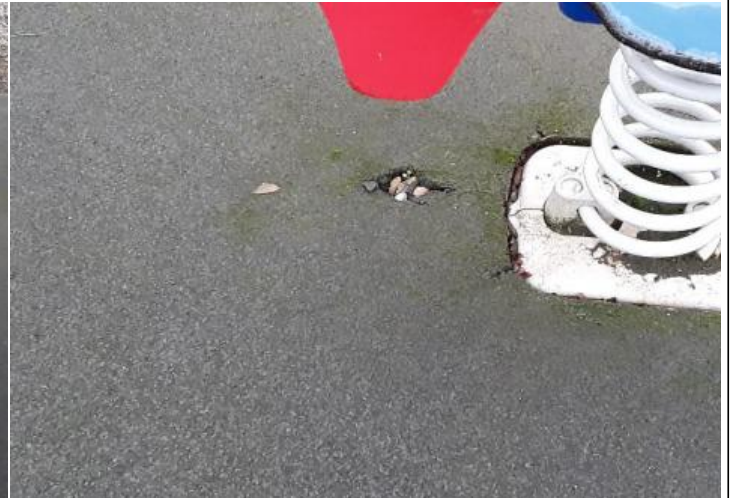
Item: Rocking Equipment - Spring Horse
Manufacturer: Ledon

Finding: There is damage to the surface

Action: Repair the damaged areas of surfacing

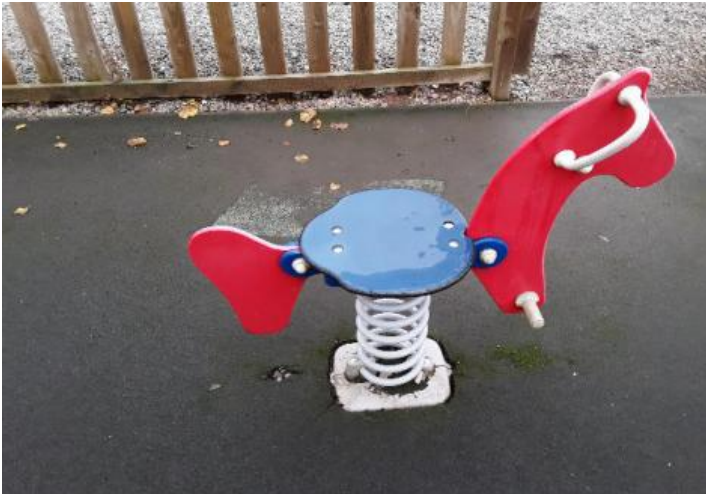
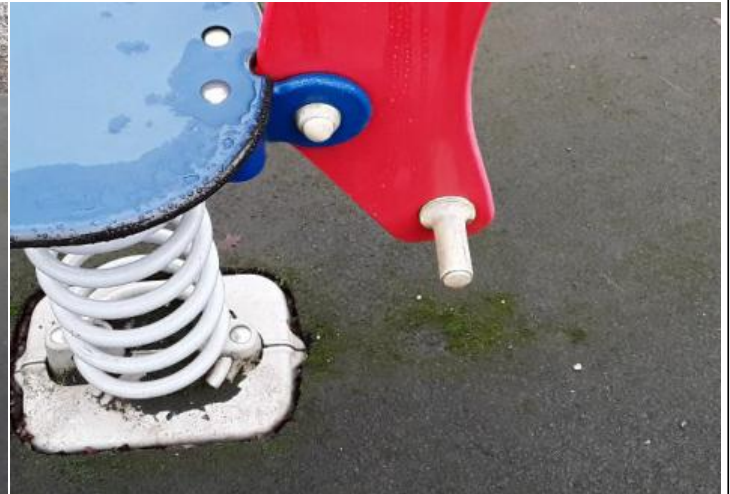
Item: Rocking Equipment - Spring Horse
Manufacturer: Ledon

Finding: The end of handgrips and/or footrests have a cross section of less than 15cm² and fail to meet the requirements of BS EN 1176 Part 6

Action: Monitor - No remedial work recommended

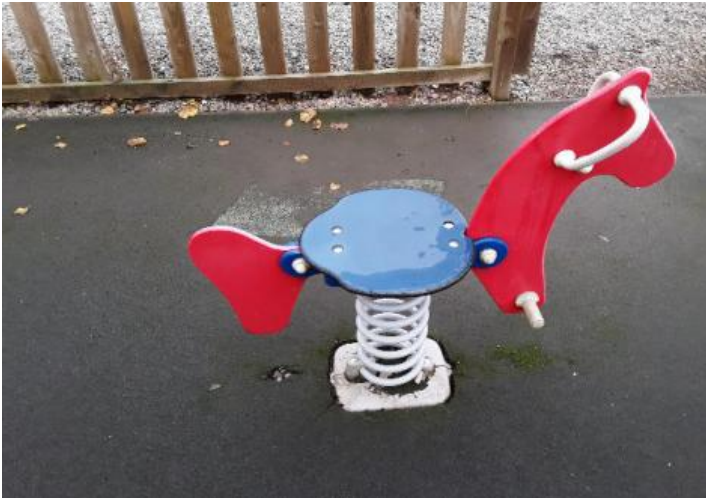
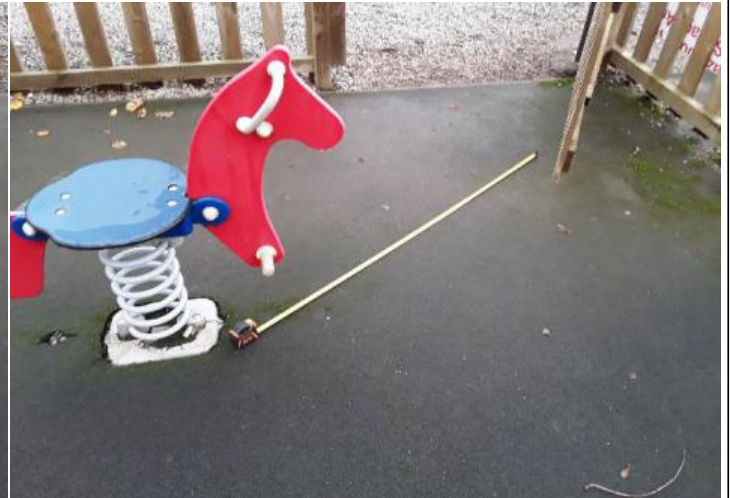
Item: Rocking Equipment - Spring Horse
Manufacturer: Ledon

Finding: The gate forms a hard object within the impact area of the equipment when in the open position

Action: Adjust the gate

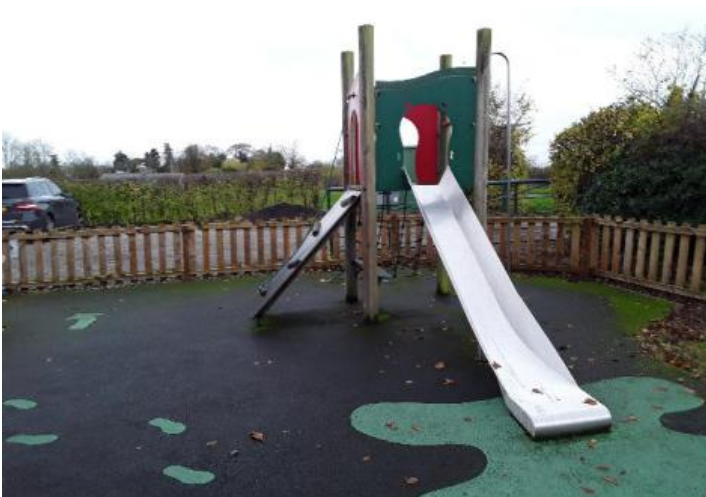
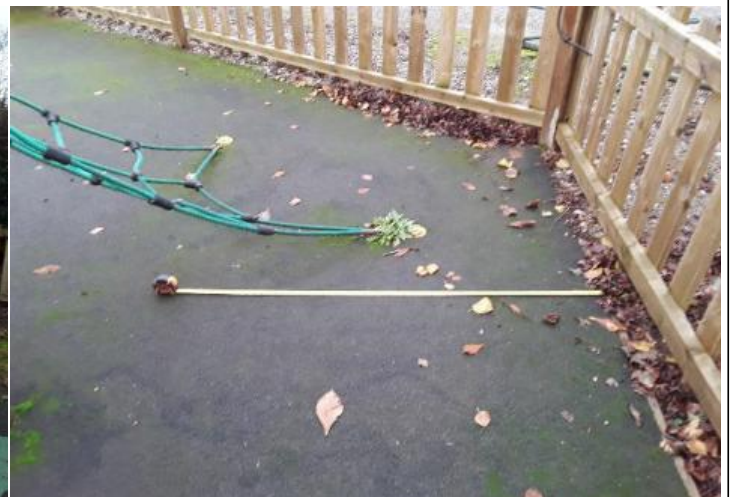
Item: Activity Equipment - Multi Play (Junior)
Manufacturer: Playdale Playgrounds Ltd

Finding: The fence forms a hard object within the falling space of the equipment and there is also insufficient surfacing provided in contravention of BS EN 1176 Part 1

Action: Monitor - no remedial work recommended

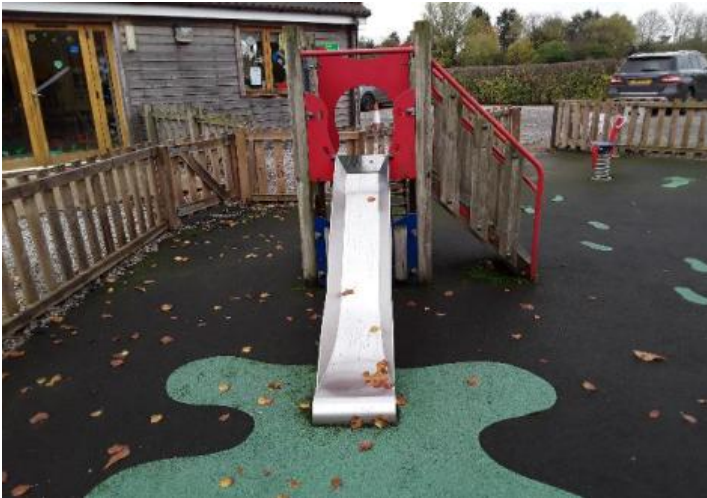
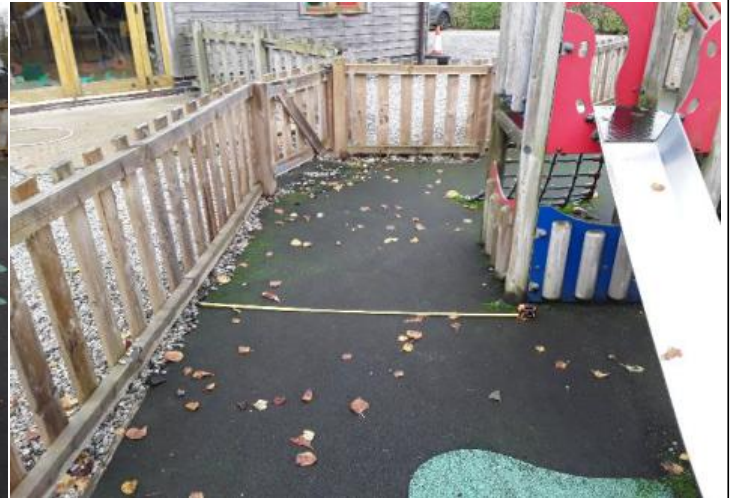
Item: Activity Equipment - Multi Play (Toddler)
Manufacturer: Playdale Playgrounds Ltd

Finding: The fence forms a hard object within the falling space of the equipment and there is also insufficient surfacing provided in contravention of BS EN 1176 Part 1

Action: Monitor - no remedial work recommended

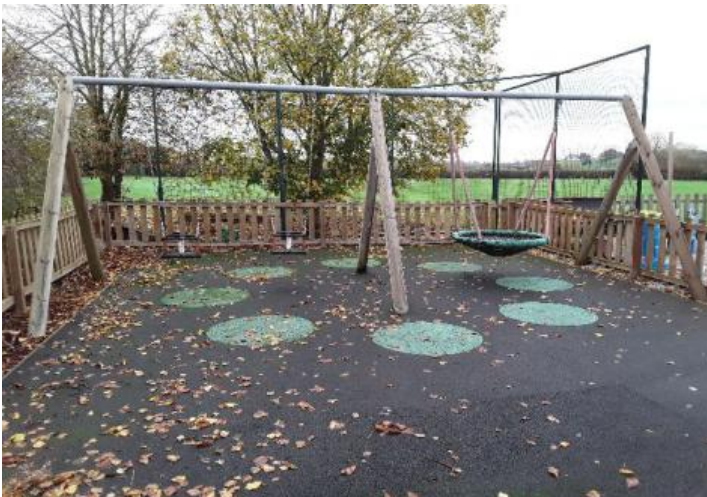
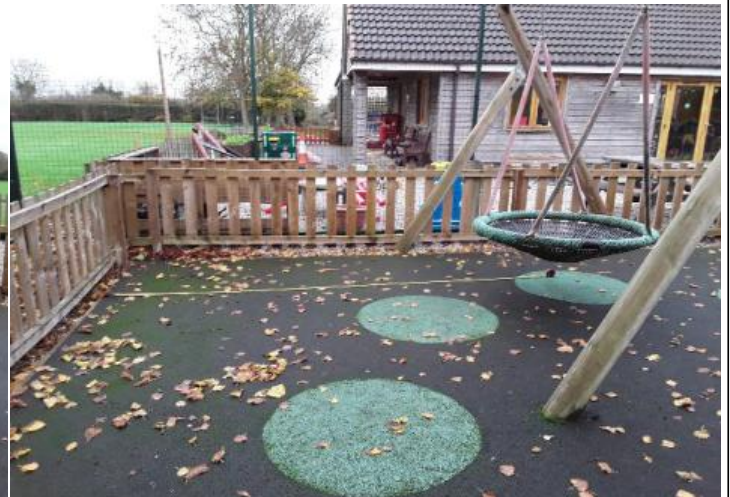
Item: Swings - 2 Bay 2 Cradle 1 Basket
Manufacturer: Playdale Playgrounds Ltd

Finding: The fence forms a hard object within the falling space of the equipment and there is also insufficient surfacing provided in contravention of BS EN 1176 Part 1

Action: Monitor - no remedial work recommended

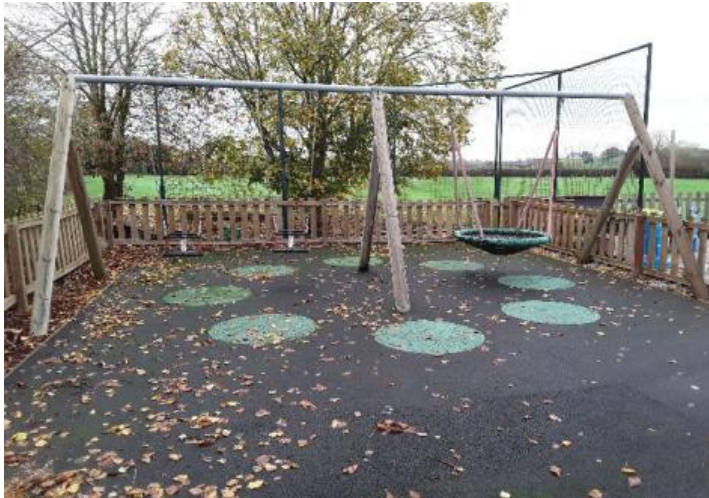
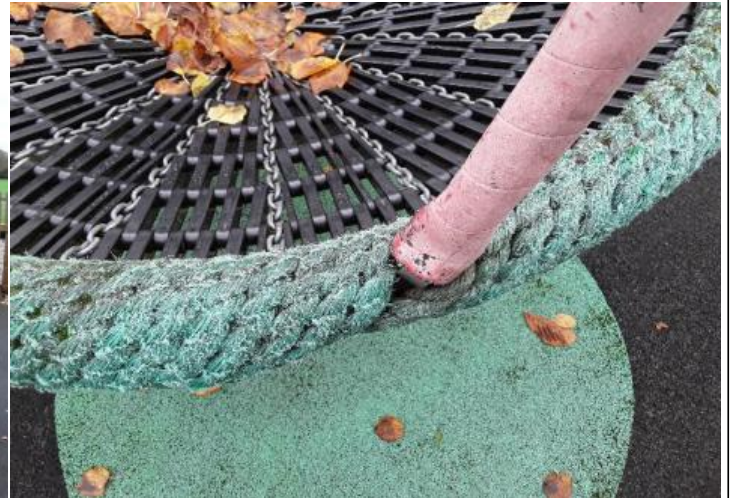
Item: Swings - 2 Bay 2 Cradle 1 Basket
Manufacturer: Playdale Playgrounds Ltd

Finding: The seat connection cannot be inspected fully as the chain cover cannot be lifted

Action: Cut the cover to allow access to the shackle and assess the wear

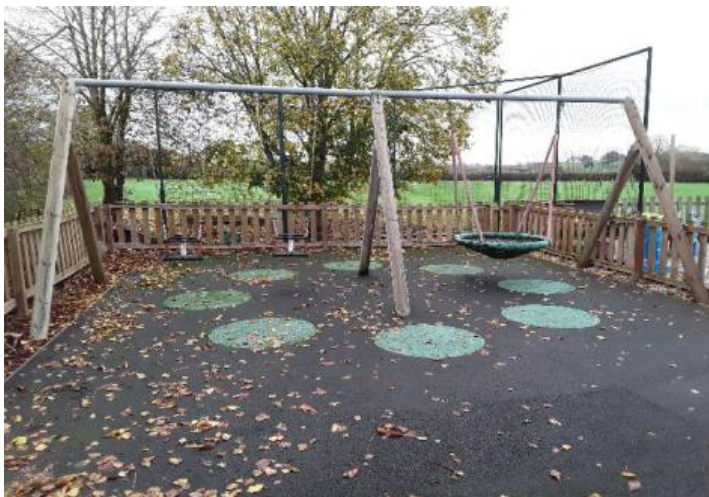
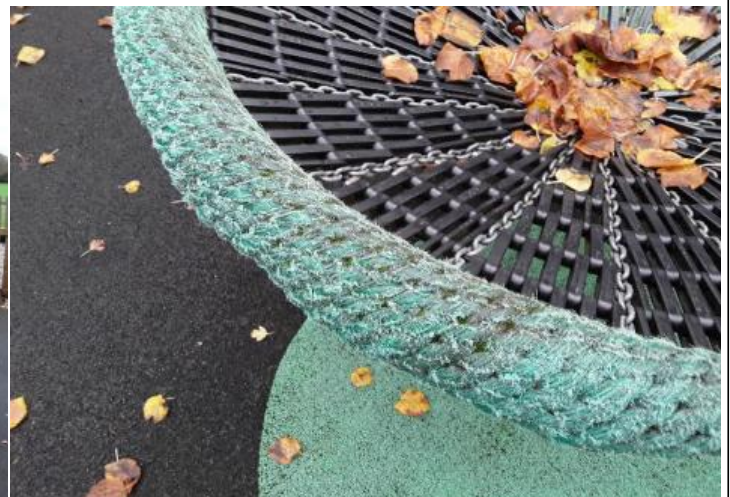
Item: Swings - 2 Bay 2 Cradle 1 Basket
Manufacturer: Playdale Playgrounds Ltd

Finding: The ropes/nets are worn/damaged in places

Action: Monitor for any further deterioration and repair or replace as required

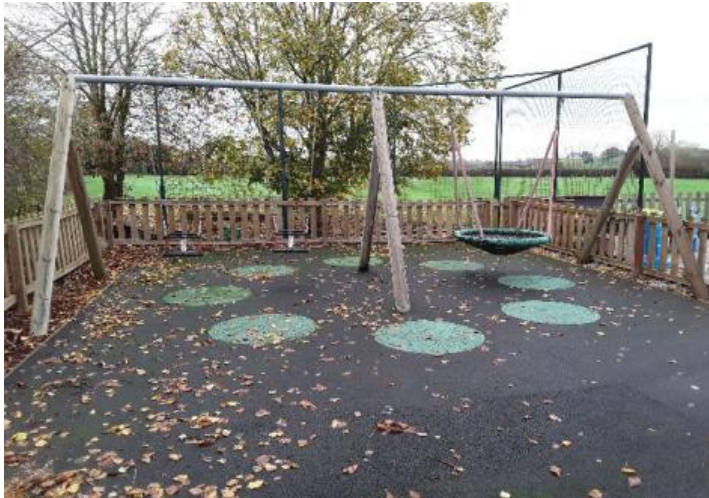
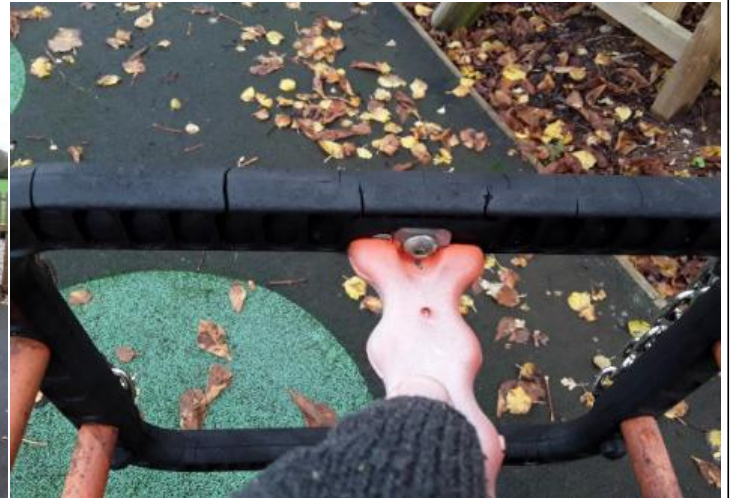
Item: Swings - 2 Bay 2 Cradle 1 Basket
Manufacturer: Playdale Playgrounds Ltd

Finding: The seat has minor damage or wear

Action: Monitor for any further deterioration and replace as required

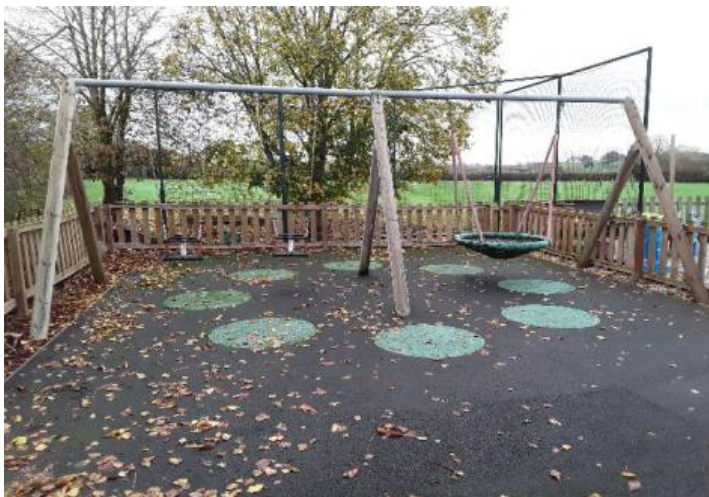
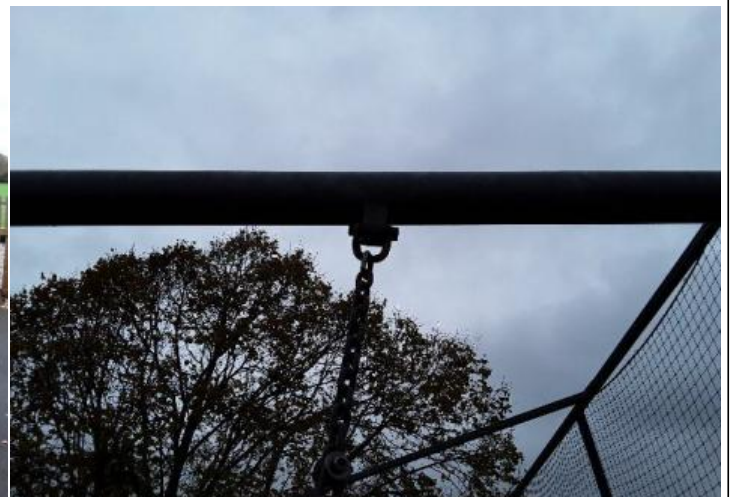
Item: Swings - 2 Bay 2 Cradle 1 Basket
Manufacturer: Playdale Playgrounds Ltd

Finding: Swings of this design should have a secondary safety device fitted to prevent collapse of the seat in the event of a joint failure to meet the requirements of BS EN 1176 Part 2

Action: Consult with manufacturer and consider providing a secondary safety device where possible

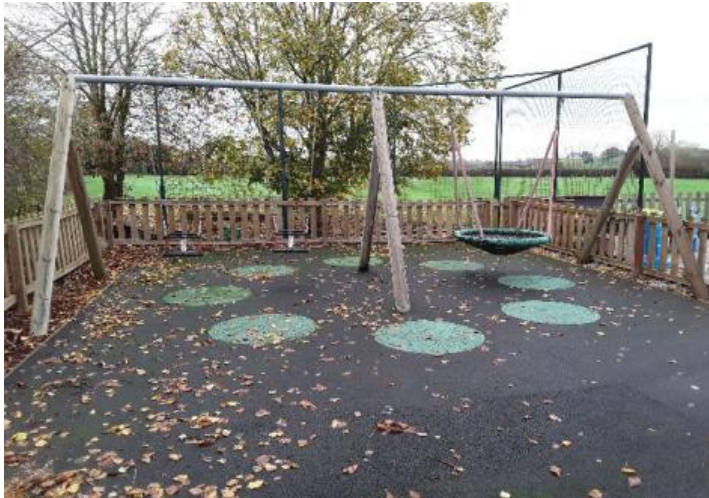
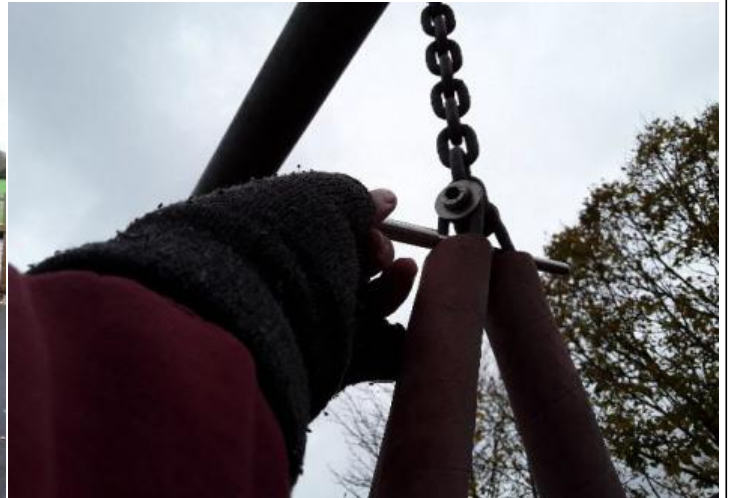
Item: Swings - 2 Bay 2 Cradle 1 Basket
Manufacturer: Playdale Playgrounds Ltd

Finding: The chain openings are in excess of the 8.6mm as recommended by BS EN 1176 **Action:** Monitor - No remedial work recommended
