# the **play inspection** company

## Annual Inspection

Newark & Sherwood District Council

Upton Cricket Club

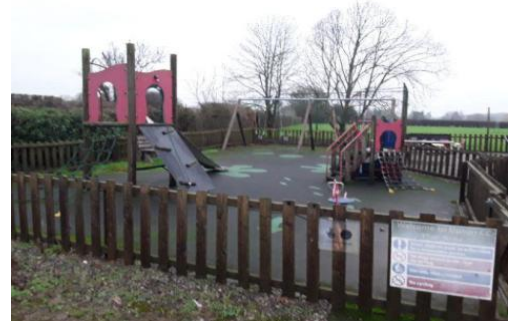
There is algae, silt or moss growth on the surface resulting in slippery conditions - Clean and treat appropriately

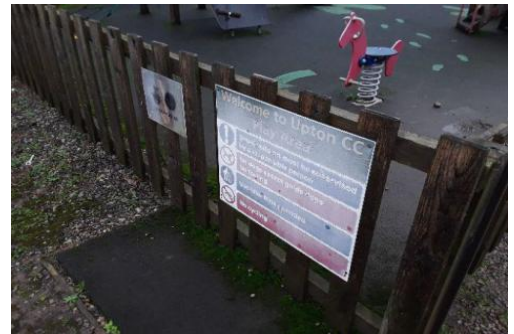
It is recommended that signage, with information including the site address, contact information for maintenance issues and emergency contact details are provided for the facility - Provide in accordance with the recommendations

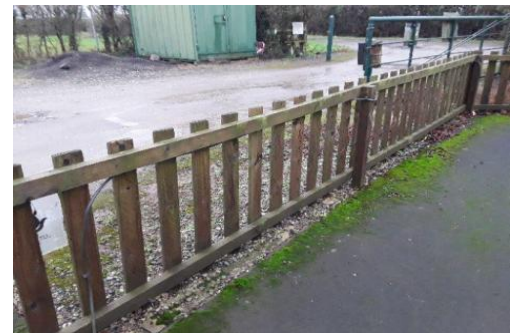
There is some evidence of rot in the timber - Monitor for any further deterioration and replace as required

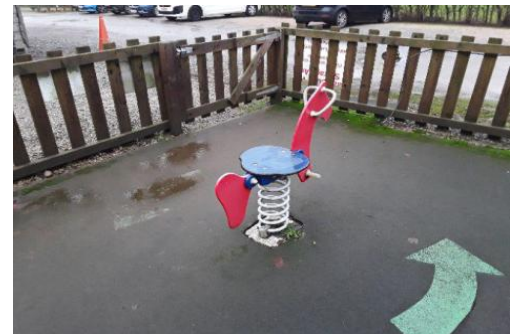
The end of handgrips and/or footrests have a cross section of less than 15cm<sup>2</sup> and fail to meet the requirements of BS EN 1176 Part 6 - Monitor - No action given the risk assessment

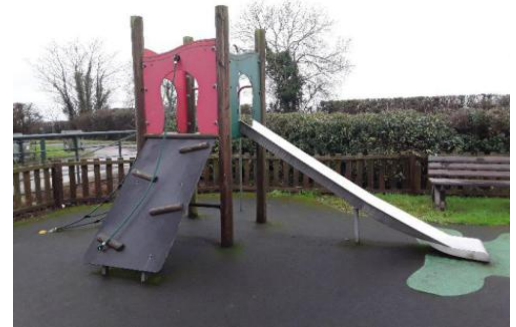
The surfacing dimensions are short and do not meet with the requirements of the current applicable standard - Monitor - No action given the risk assessment

The timber has a number of splits/shakes or air cracks and this may affect the stability or allow water ingress which will accelerate the rotting process. Timber splits may also create rough / splintering edges. - Monitor, sand down any rough edges and ensure the splits do not cross through fixing points of the structure and/or cause any instability

A number of fixing(s) have worked loose - Secure all loose fixings

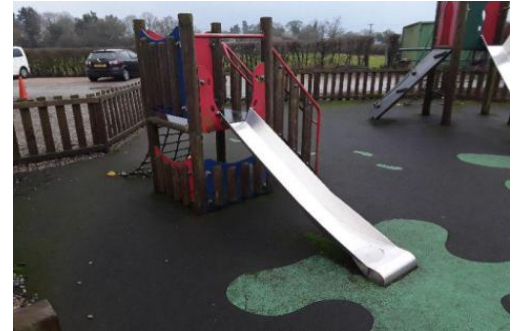
The fence forms a hard object within the falling space of the equipment and there is also insufficient surfacing provided in contravention of BS EN 1176 Part 1 - Monitor - No action given the risk assessment

The timber has a number of splits/shakes or air cracks and this may affect the stability or allow water ingress which will accelerate the rotting process. Timber splits may also create rough / splintering edges. - Monitor, sand down any rough edges and ensure the splits do not cross through fixing points of the structure and/or cause any instability

The paintwork on this item has been damaged or worn exposing the metal underneath which is rusting / corroding - Treat affected areas and repaint

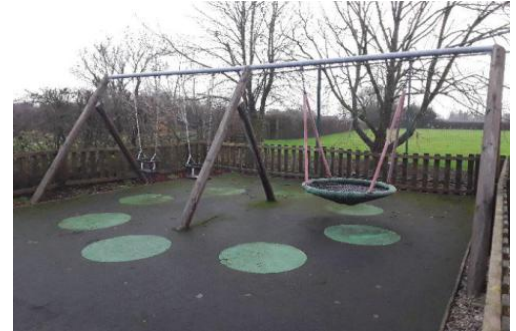
The safety surface around the area is beginning to wear - Monitor for any further deterioration and repair as required

BS EN 1176 requires an additional 0.5m of unobstructed space at each end of the swing surfacing area. This is a relatively low risk finding and no remedial action is recommended at this point. - Monitor - No action given the risk assessment

The timber has a number of splits/shakes or air cracks and this may affect the stability or allow water ingress which will accelerate the rotting process. Timber splits may also create rough / splintering edges. - Monitor, sand down any rough edges and ensure the splits do not cross through fixing points of the structure and/or cause any instability

The seat has minor damage or wear - Monitor for any further deterioration and replace as required

The bushes are worn or missing - Replace worn or missing bushes

There is some wear to the shackles - Monitor for any further deterioration and replace when 40% worn

The surface has subsided in some areas - Monitor for any further deterioration and repair as required

There is some evidence of rot in the timber posts - Monitor for any further deterioration and replace as required

The swing seat frames are corroding - Monitor for any further deterioration and replace as required

There is some notable evidence of chain wear - Monitor for any further deterioration and replace when 40% worn

Swings of this design should have a secondary safety mechanism fitted to prevent collapse of the seat in the event of a joint failure to comply with BS EN 1176 Part 2, however this swing was installed prior to the standards being updated in 2018 and the manufacturer has confirmed that the joint was independently cycle tested by BSi - Monitor use and check the joint and fixing security regularly

The seat connection cannot be inspected fully as the chain cover cannot be lifted - Cut the cover to allow access to the shackle and assess the wear

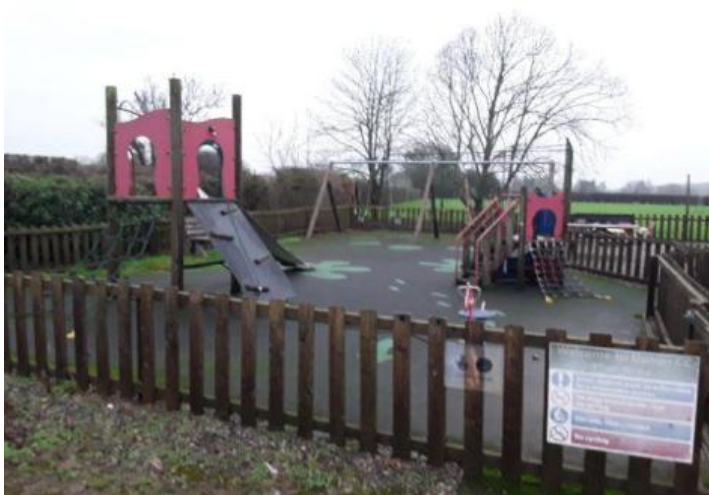
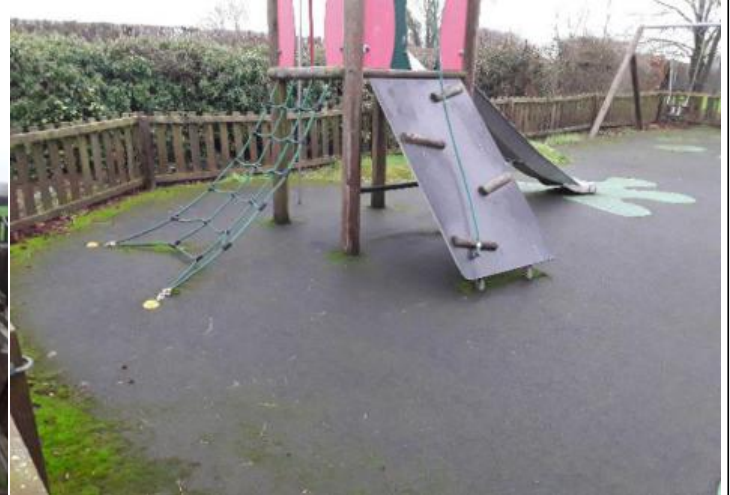
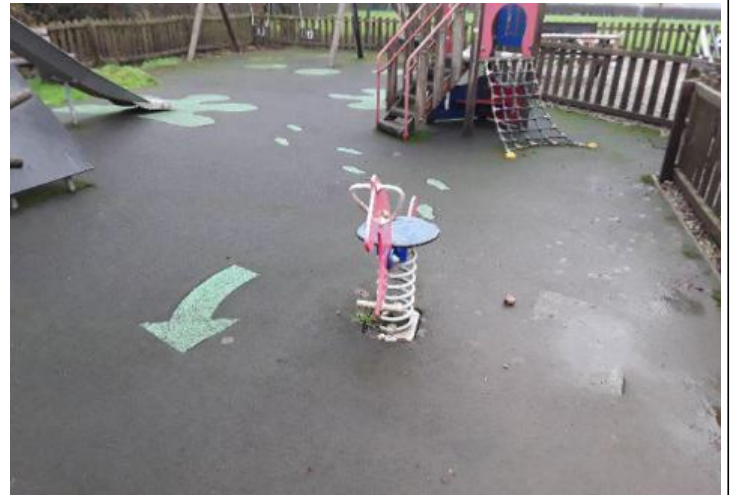
**Finding:** There is algae, silt or moss growth on the surface resulting in slippery conditions

**Action:** Clean and treat appropriately

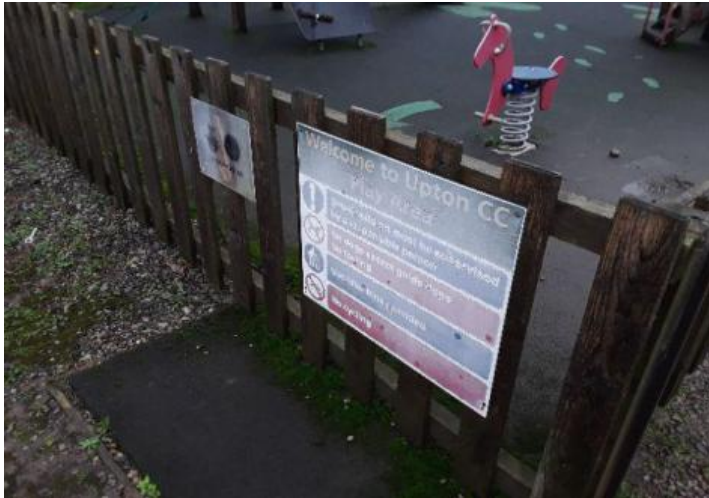
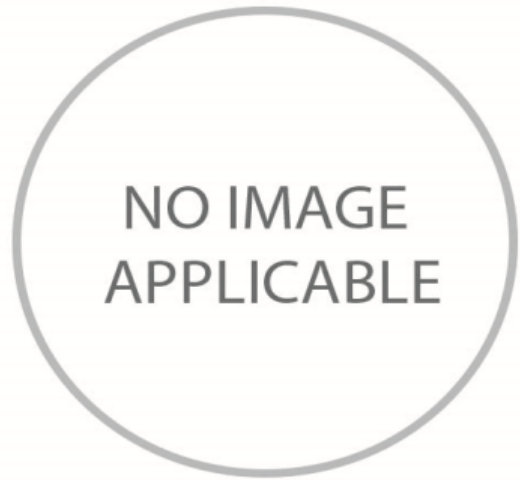
**Finding:** It is recommended that signage, with information including the site address, contact information for maintenance issues and emergency contact details are provided for the facility

**Action:** Provide in accordance with the recommendations

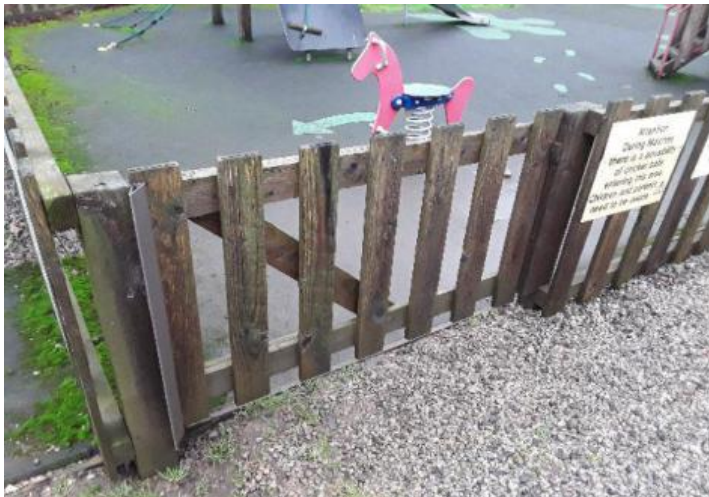
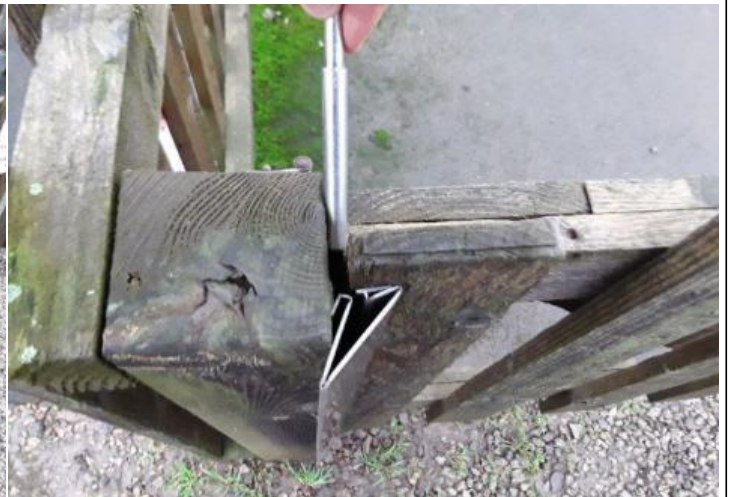
**Finding:** There are openings that are less than 12mm that could trap or crush fingers

**Action:** Provide a 12mm gap throughout full range of motion at both sides of gate

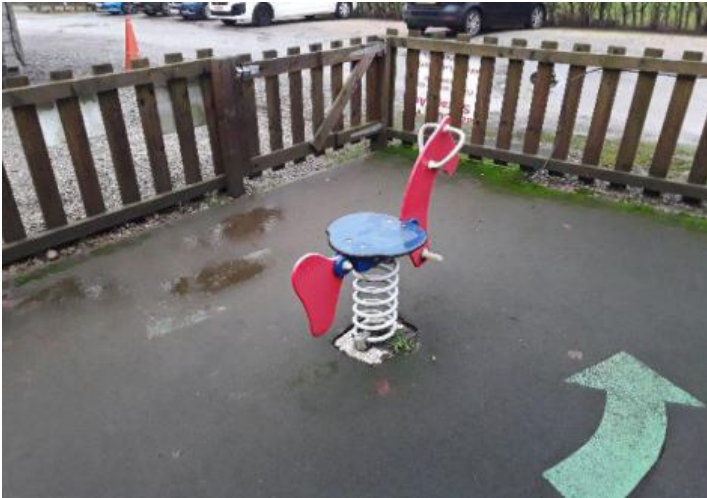
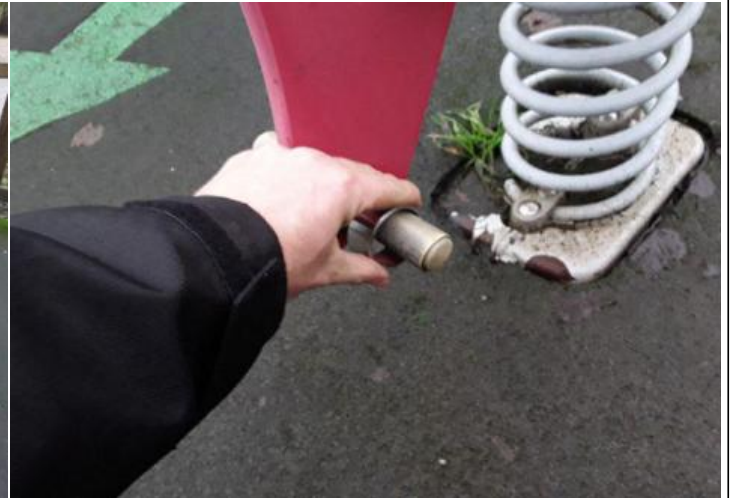
**Finding:** The end of handgrips and/or footrests have a cross section of less than 15cm<sup>2</sup> and fail to meet the requirements of BS EN 1176 Part 6  
**Action:** Monitor - No action given the risk assessment

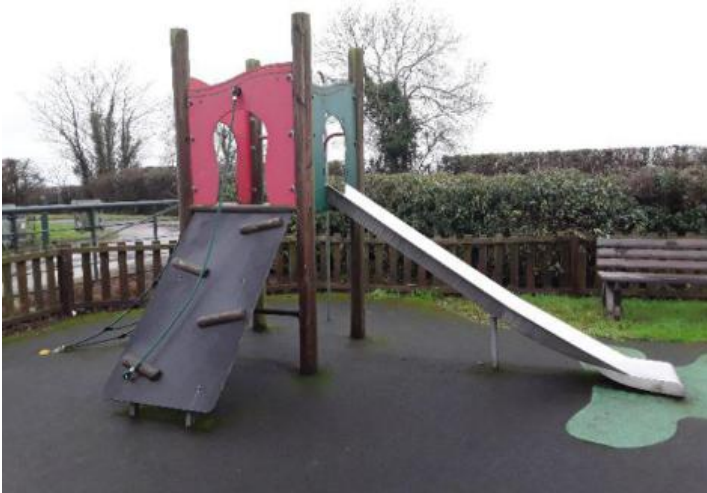
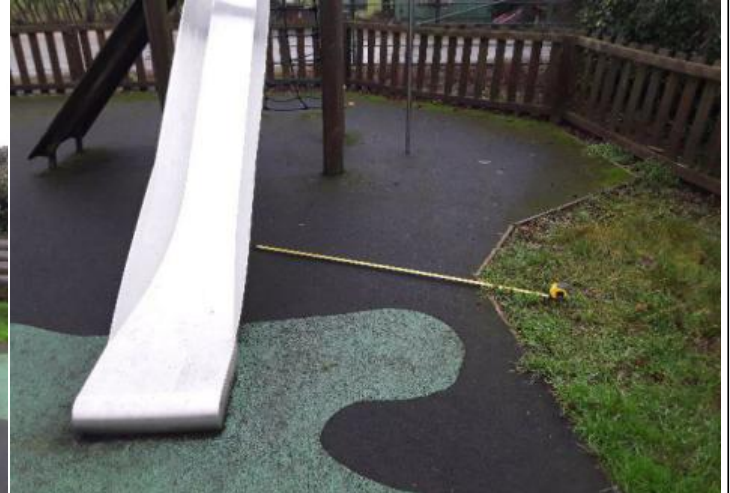
**Finding:** The surfacing dimensions are short and do not meet with the requirements of the current applicable standard  
**Action:** Monitor - No action given the risk assessment

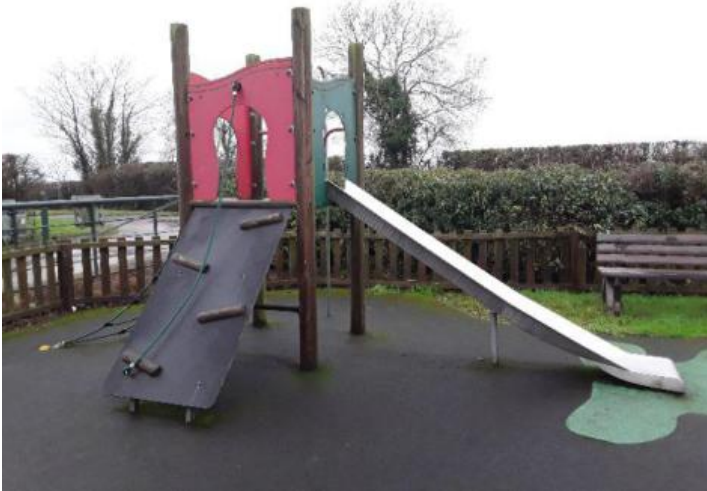
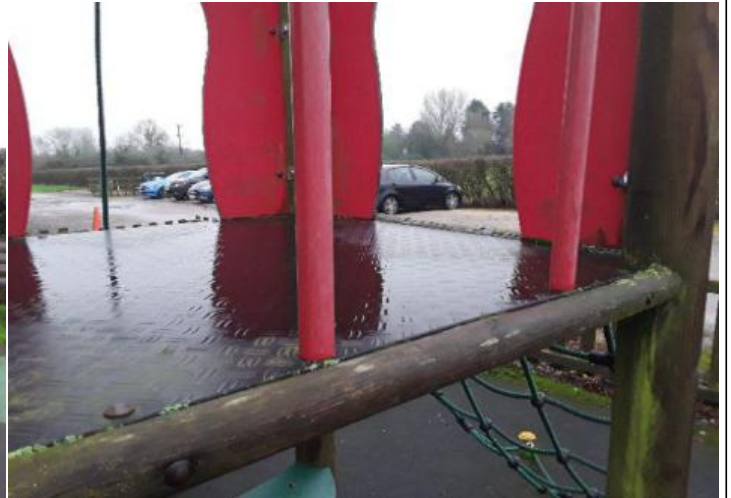
**Finding:** There is algae or moss on the surface of the equipment

**Action:** Clean and treat appropriately

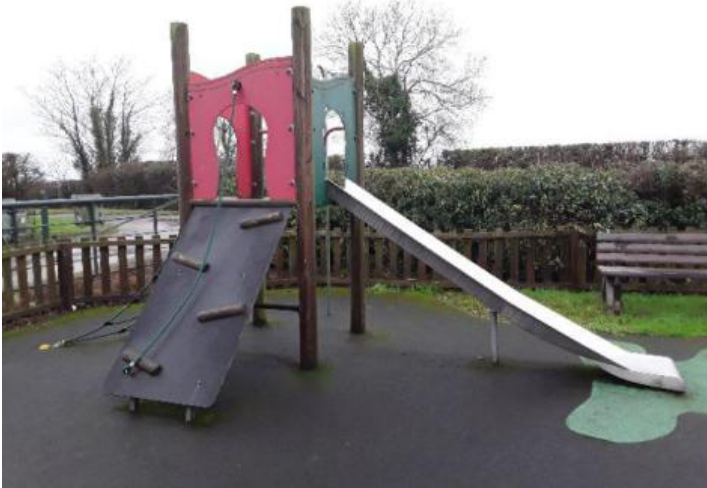
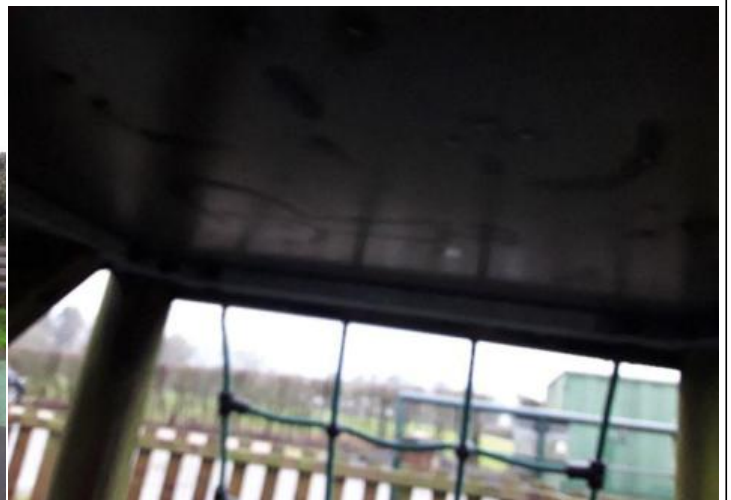
**Finding:** There is offensive graffiti present

**Action:** Remove as soon as practicable

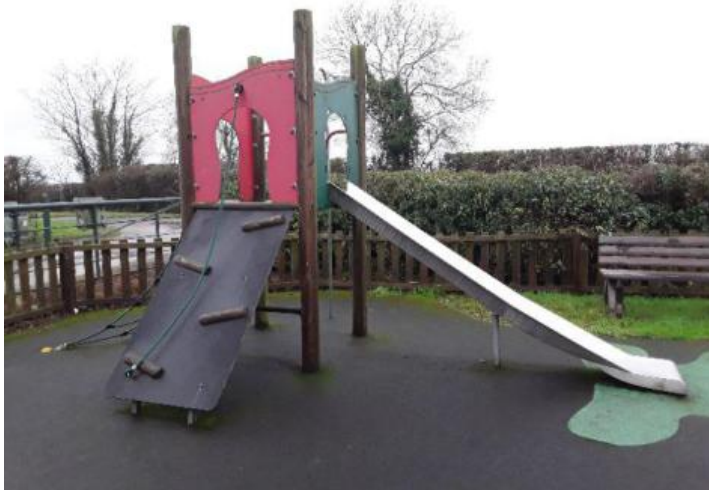
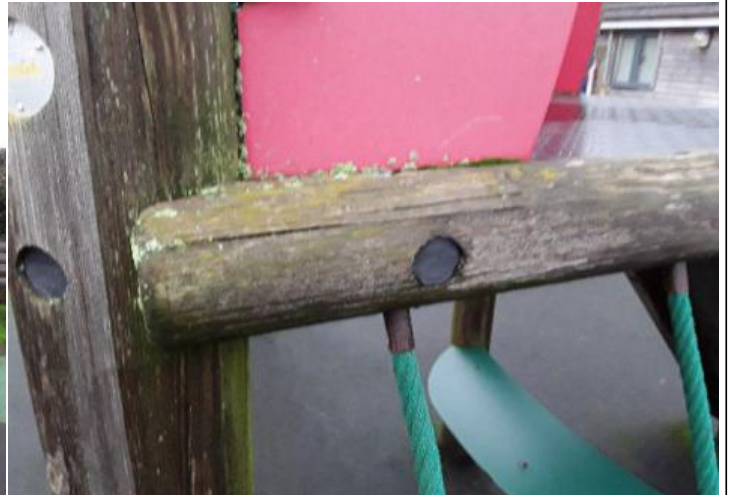
**Finding:** The timber has a number of splits/shakes or air cracks and this may affect the stability or allow water ingress which will accelerate the rotting process. Timber splits may also create rough / splintering edges.

**Action:** Monitor, sand down any rough edges and ensure the splits do not cross through fixing points of the structure and/or cause any instability

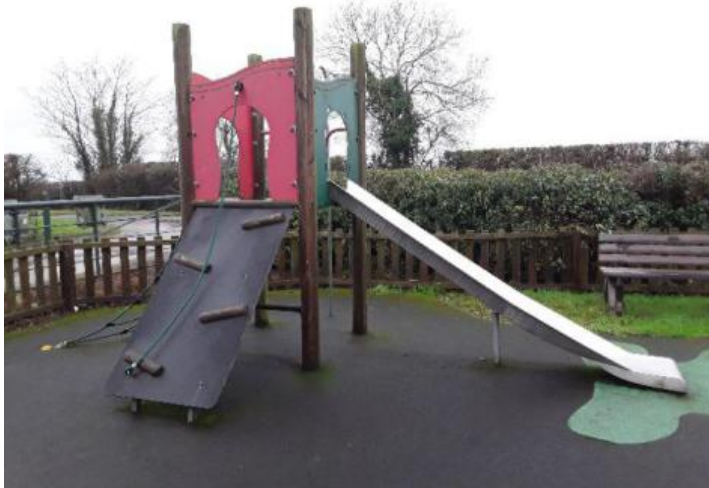
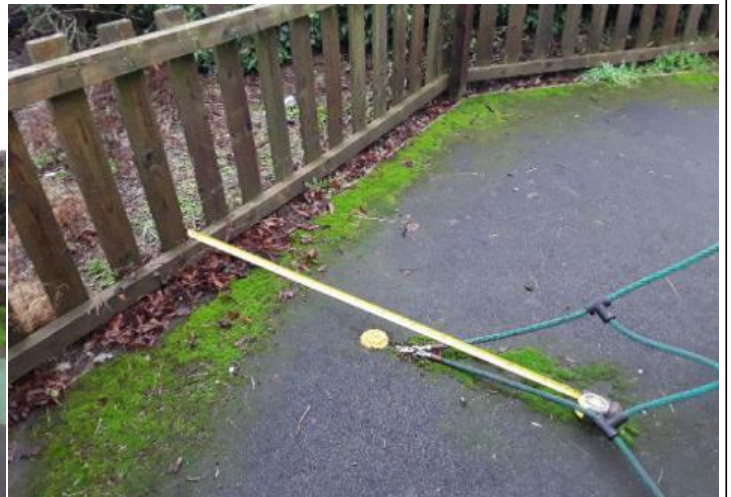
**Finding:** The fence forms a hard object within the falling space of the equipment and there is also insufficient surfacing provided in contravention of BS EN 1176 Part 1

**Action:** Monitor - No action given the risk assessment

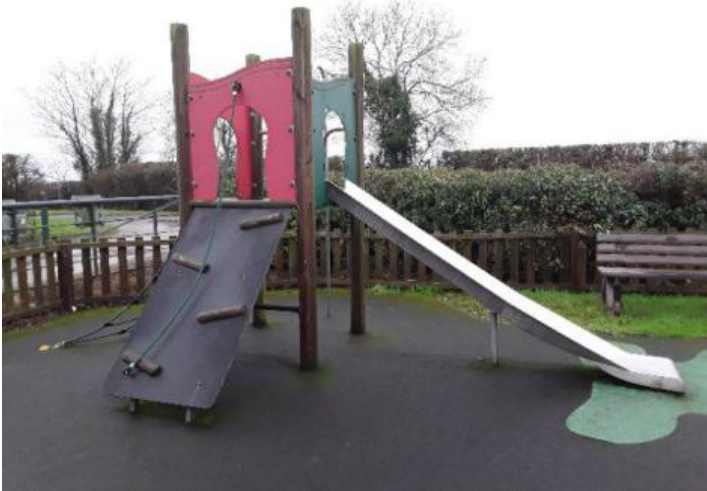
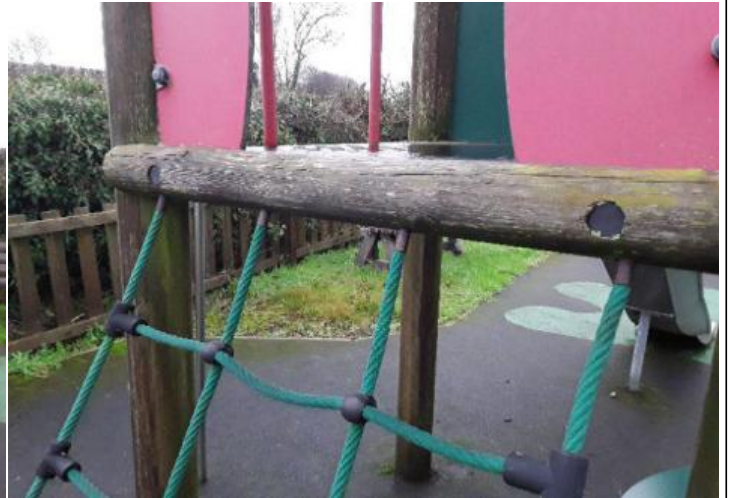
**Finding:** A number of fixing(s) have worked loose

**Action:** Secure all loose fixings

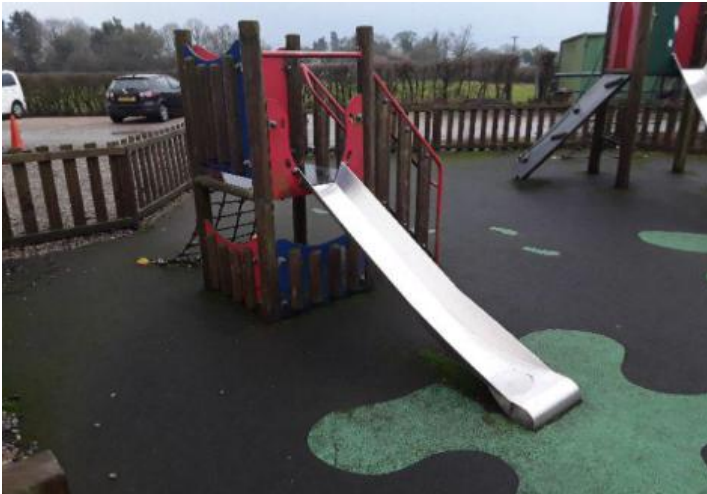
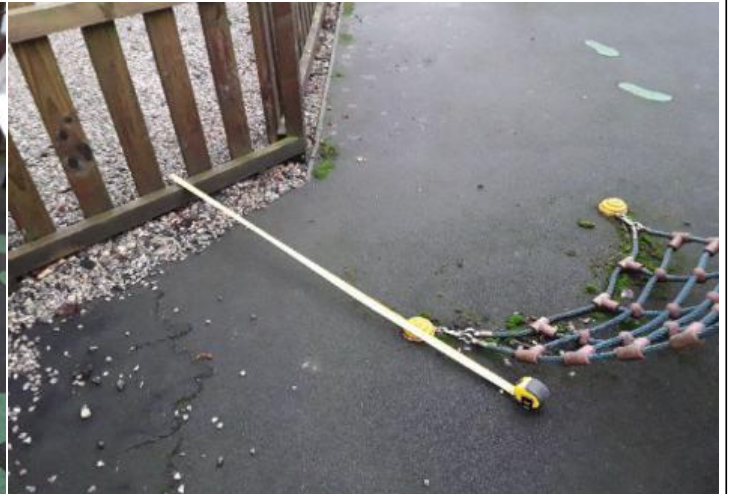
**Finding:** The fence forms a hard object within the falling space of the equipment and there is also insufficient surfacing provided in contravention of BS EN 1176 Part 1

**Action:** Monitor - No action given the risk assessment

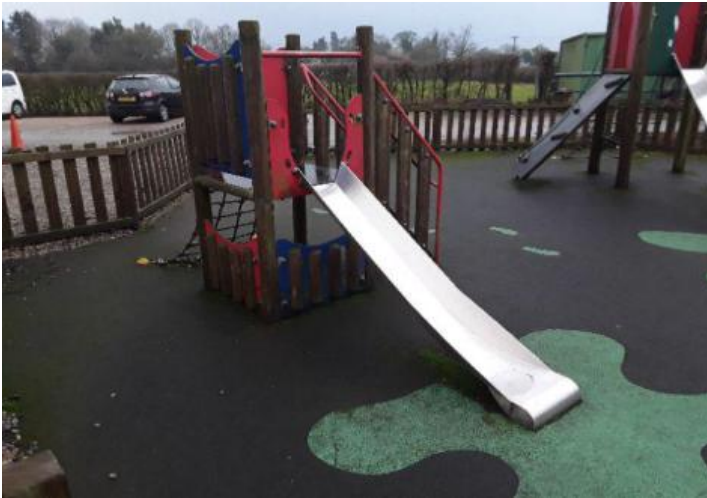
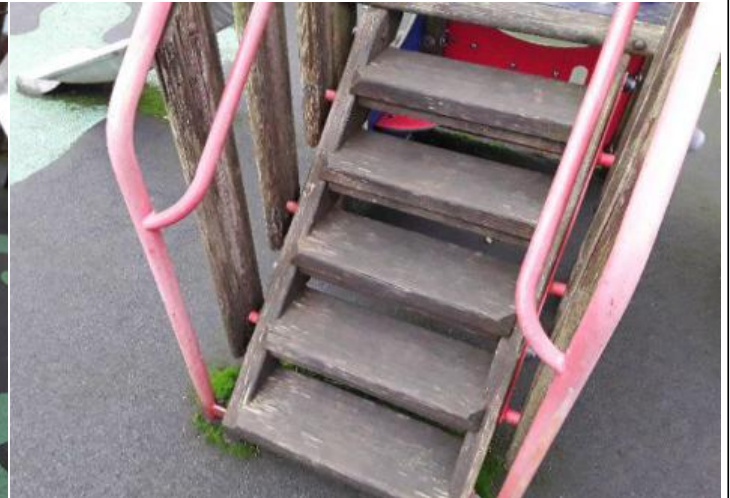
**Finding:** There is algae or moss on the surface of the equipment

**Action:** Clean and treat appropriately

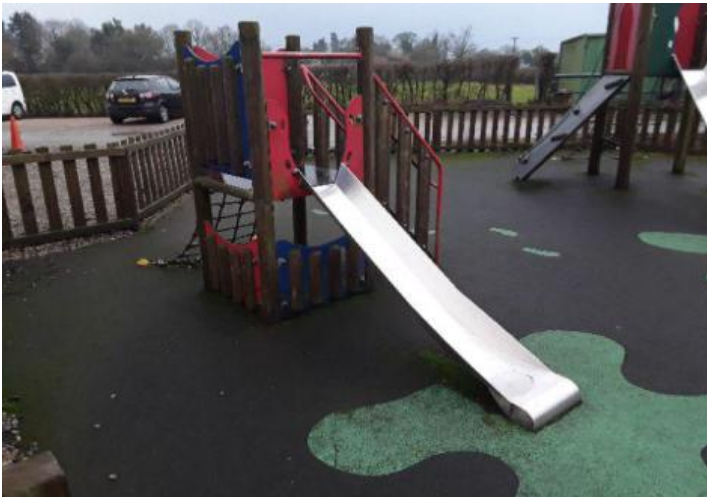
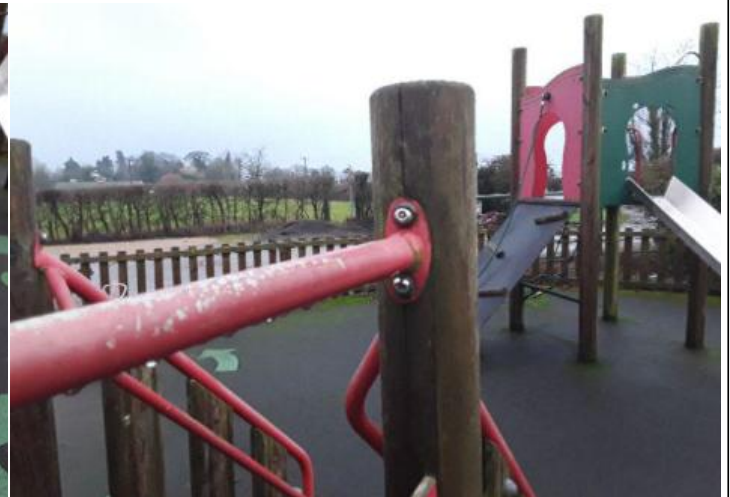
**Finding:** The timber has a number of splits/shakes or air cracks and this may affect the stability or allow water ingress which will accelerate the rotting process. Timber splits may also create rough / splintering edges.

**Action:** Monitor, sand down any rough edges and ensure the splits do not cross through fixing points of the structure and/or cause any instability

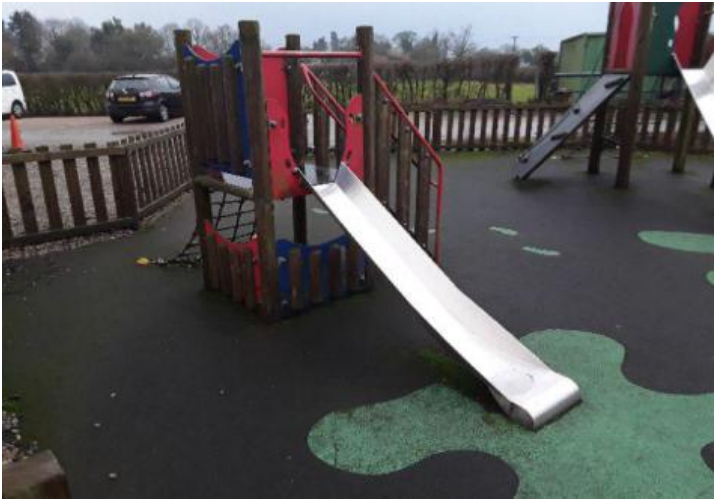
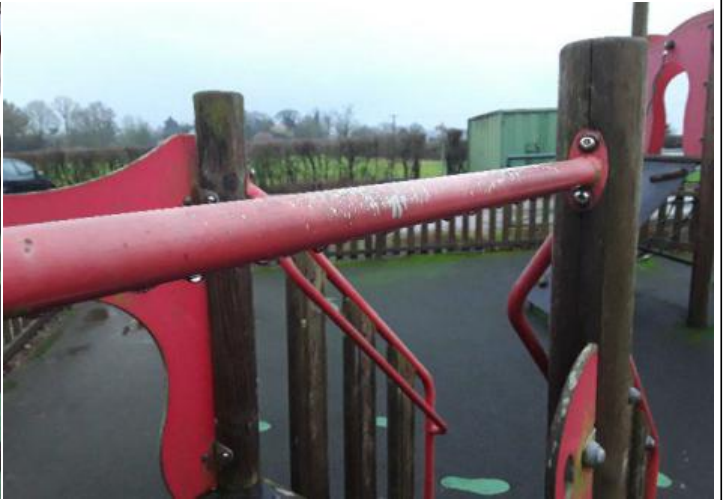
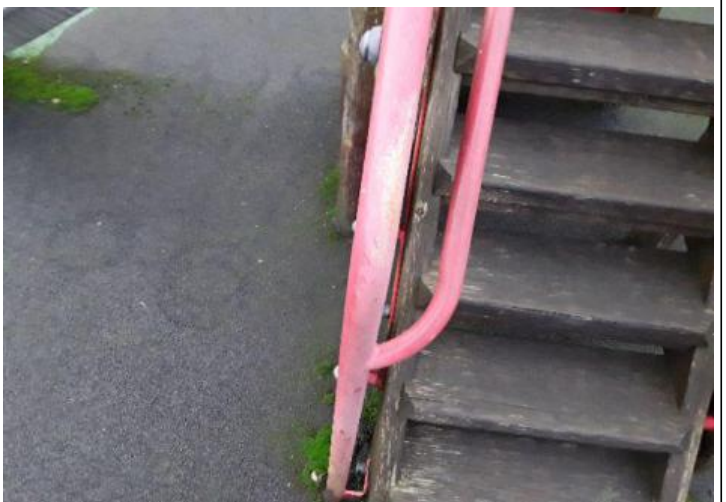
**Finding:** The paintwork on this item has been damaged or worn exposing the metal underneath which is rusting / corroding

**Action:** Treat affected areas and repaint

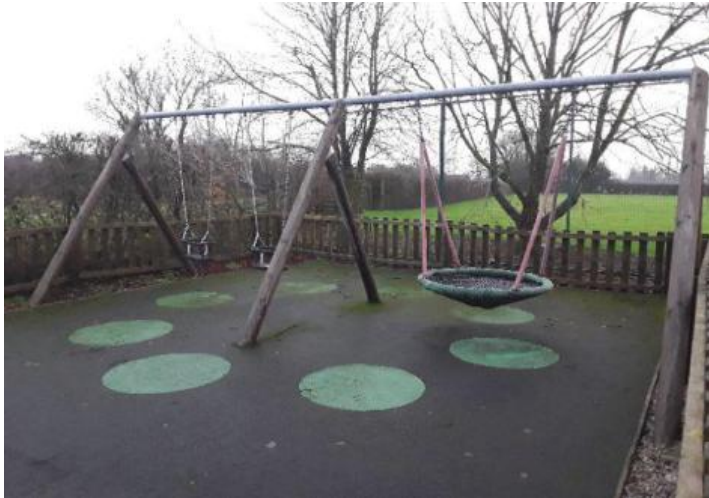
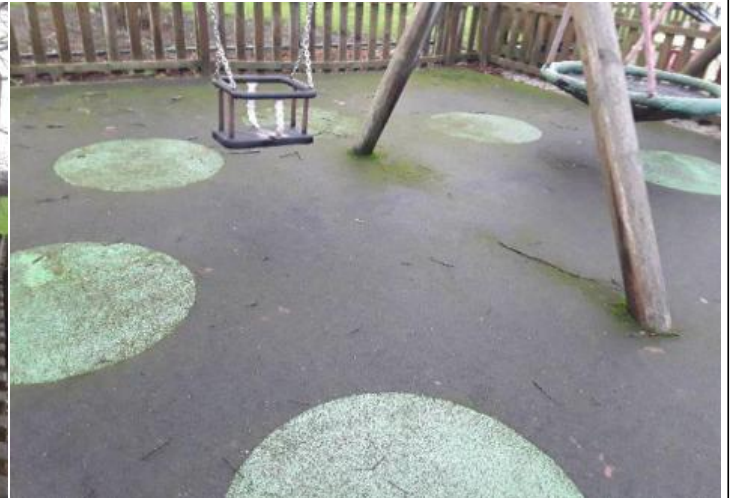
**Finding:** The safety surface around the area is beginning to wear  
**Action:** Monitor for any further deterioration and repair as required

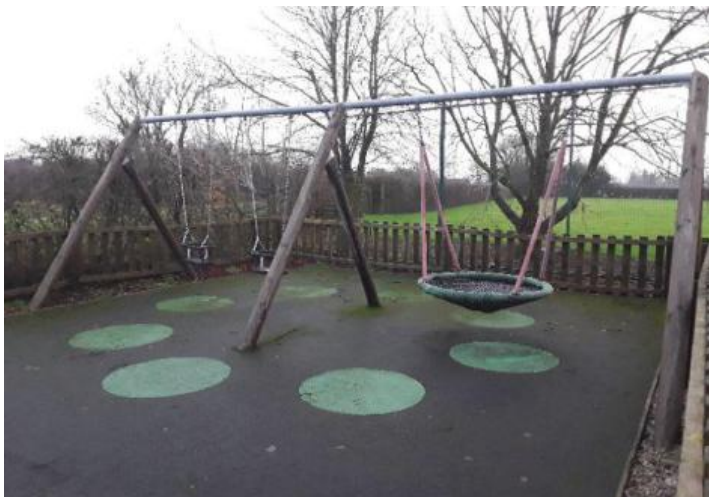
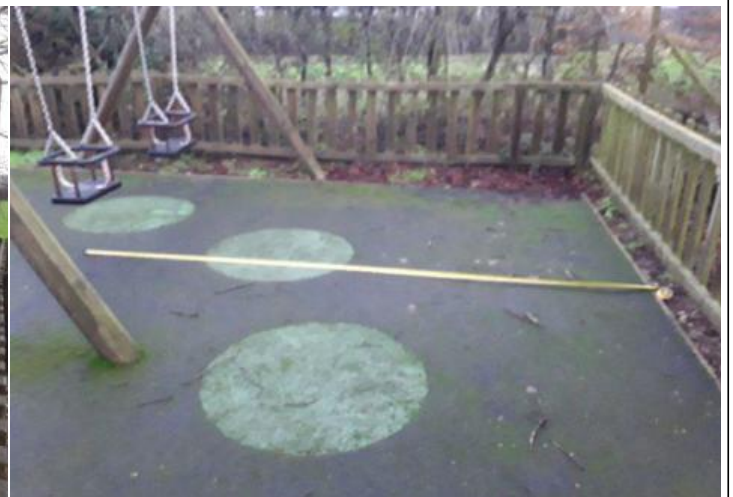
**Finding:** The surfacing dimensions are short and do not meet with the requirements of the current applicable standard  
**Action:** Monitor - No action given the risk assessment

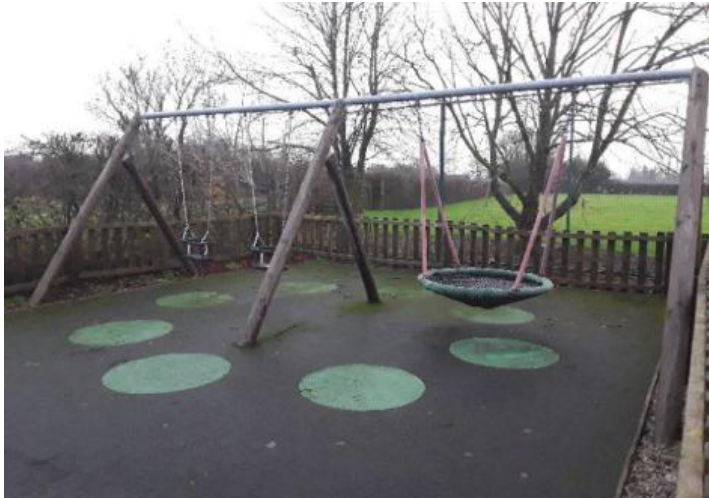
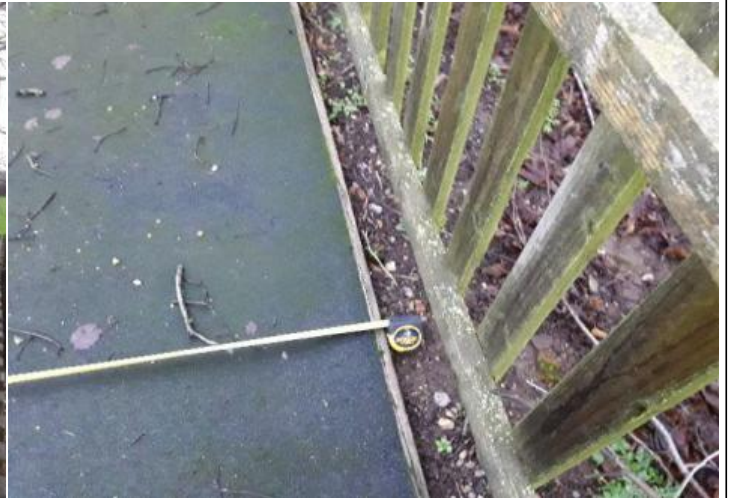
**Finding:** BS EN 1176 requires an additional 0.5m of unobstructed space at each end of the swing surfacing area. This is a relatively low risk finding and no remedial action is recommended at this point.

**Action:** Monitor - No action given the risk assessment

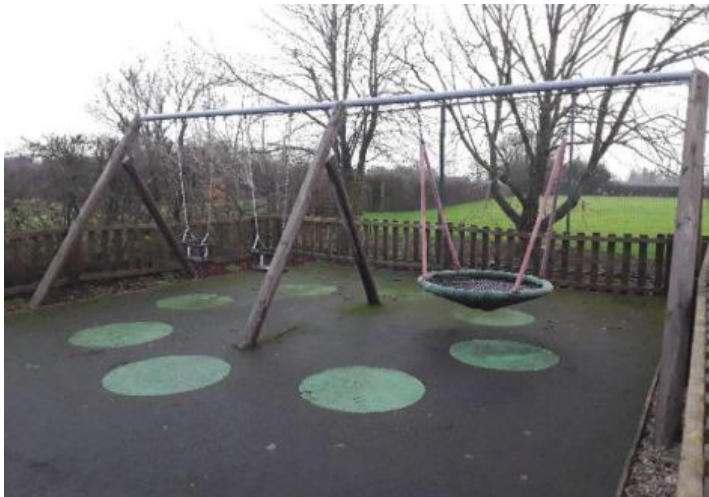
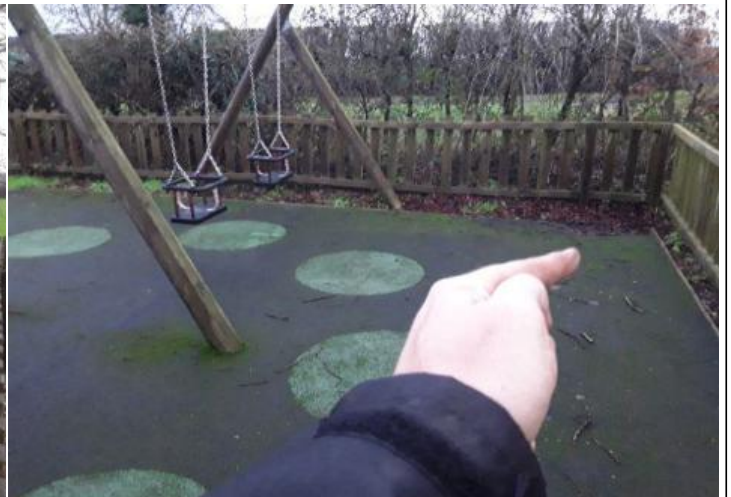
**Finding:** The surface has subsided in some areas

**Action:** Monitor for any further deterioration and repair as required

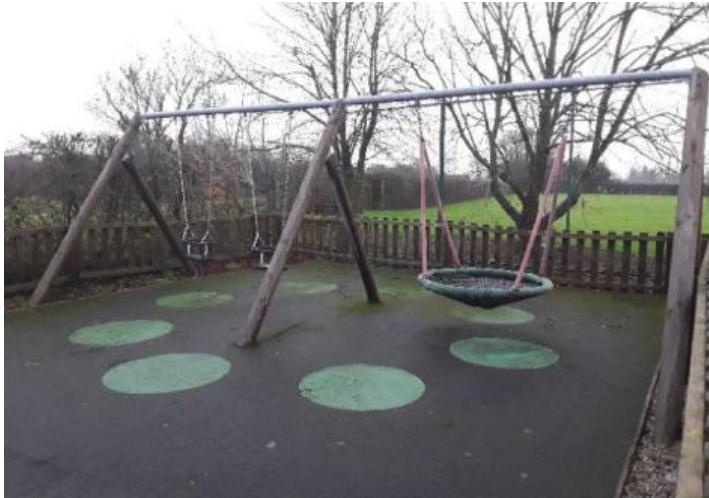
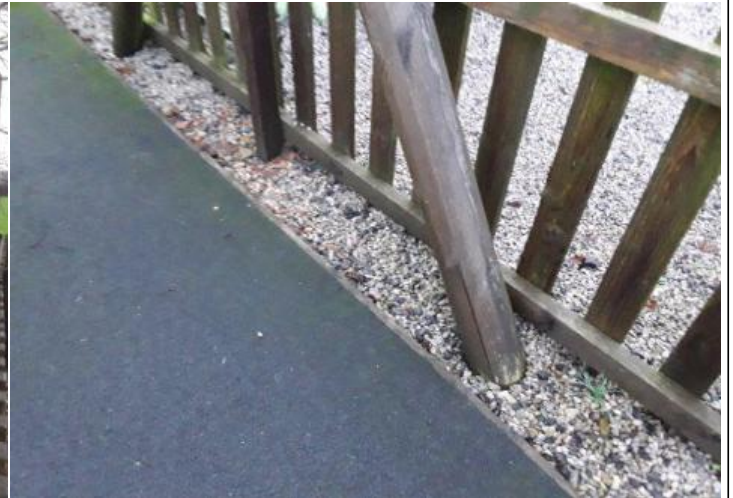
**Finding:** The timber has a number of splits/shakes or air cracks and this may affect the stability or allow water ingress which will accelerate the rotting process. Timber splits may also create rough / splintering edges.  
**Action:** Monitor, sand down any rough edges and ensure the splits do not cross through fixing points of the structure and/or cause any instability

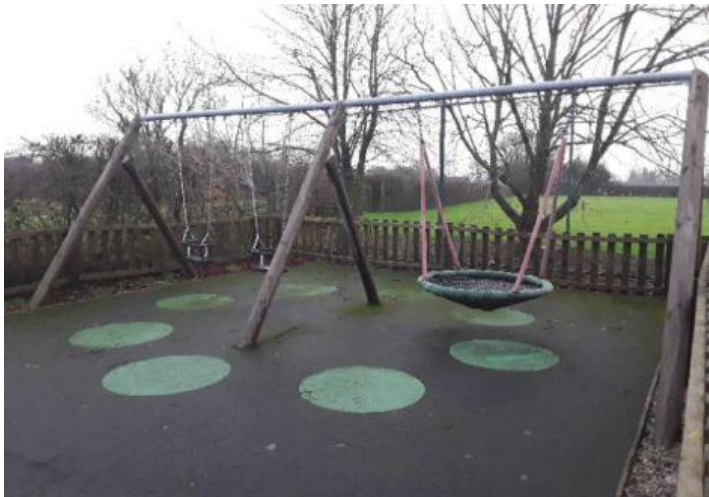
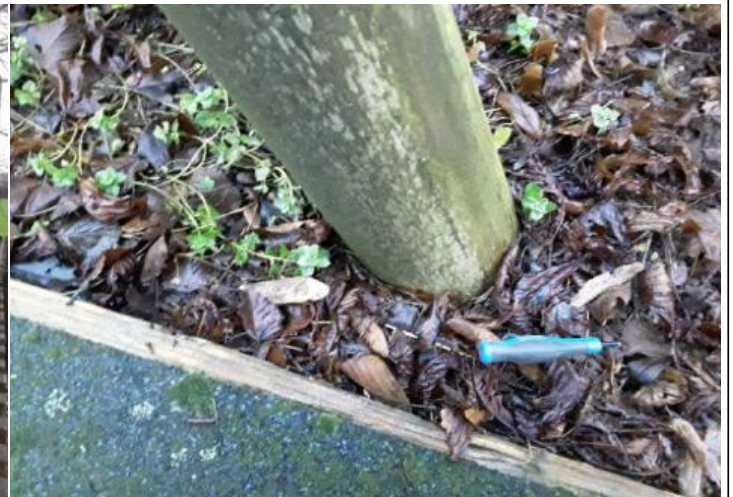
**Finding:** There is some evidence of rot in the timber posts  
**Action:** Monitor for any further deterioration and replace as required

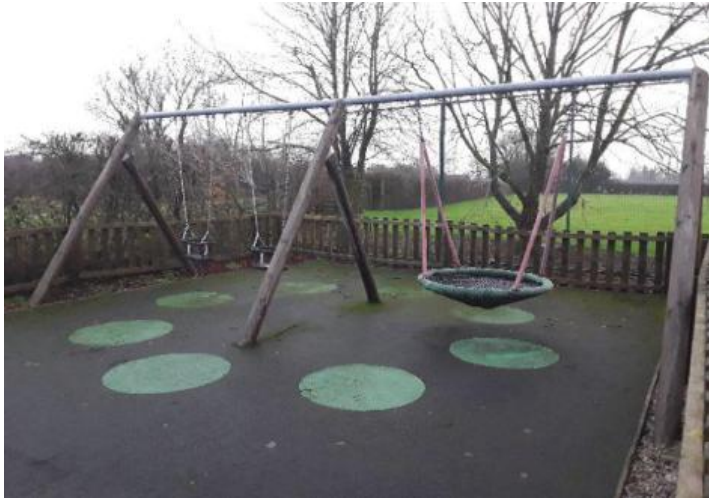
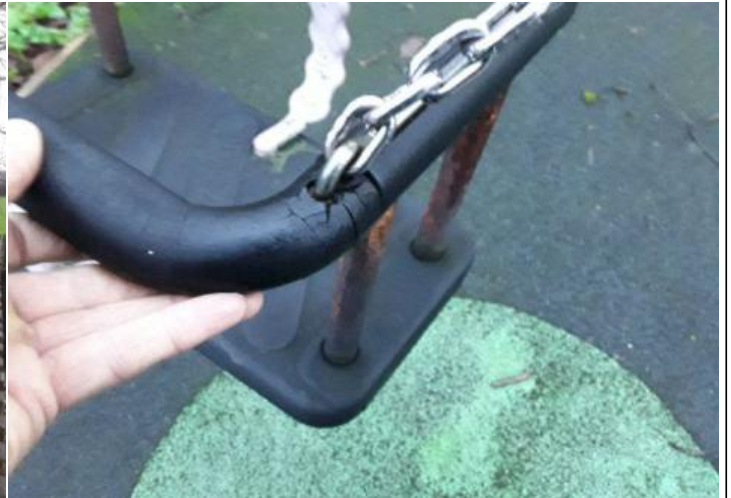
**Finding:** The seat has minor damage or wear

**Action:** Monitor for any further deterioration and replace as required

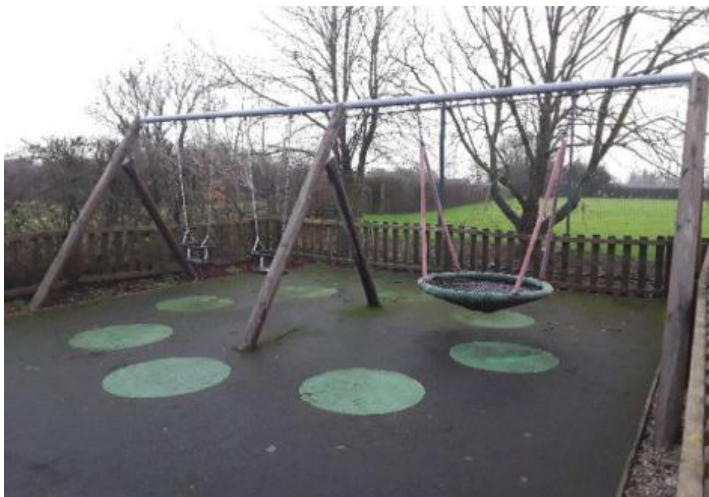
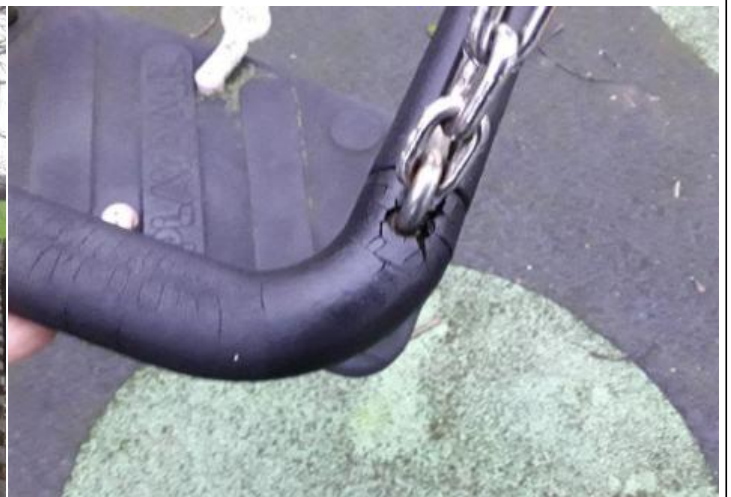
**Finding:** The swing seat frames are corroding

**Action:** Monitor for any further deterioration and replace as required

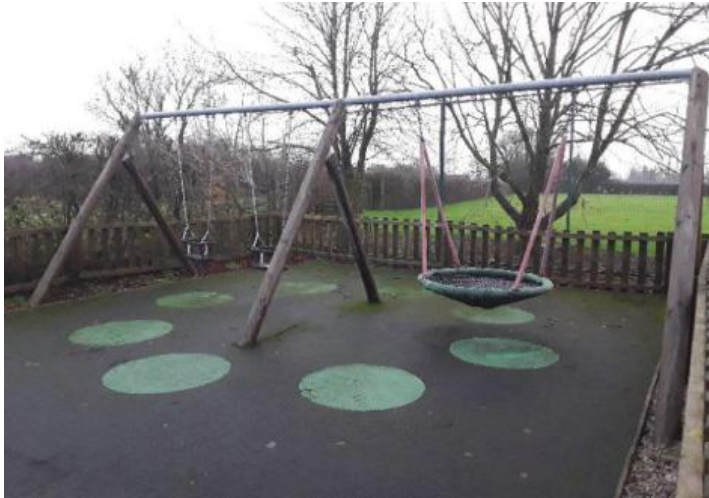
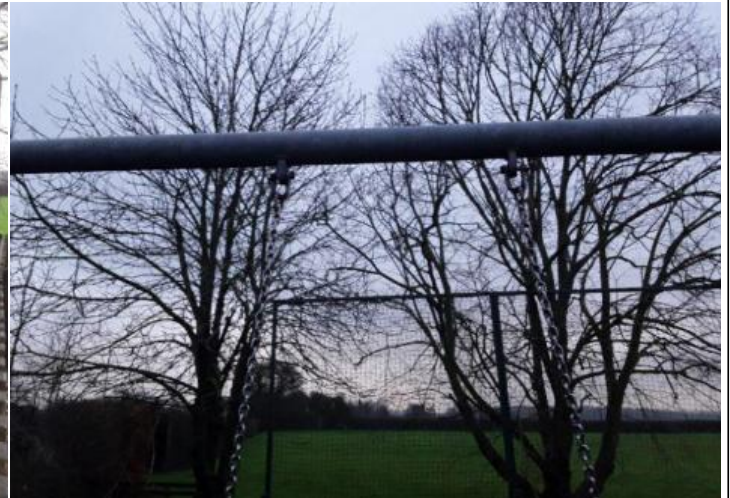
**Finding:** The bushes are worn or missing

**Action:** Replace worn or missing bushes

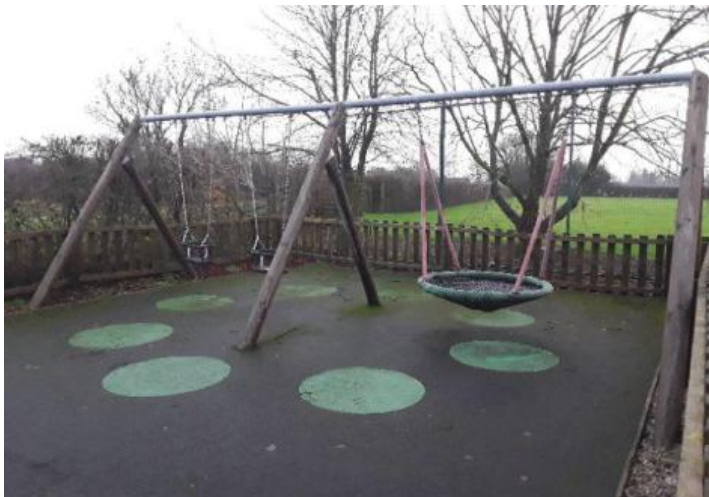
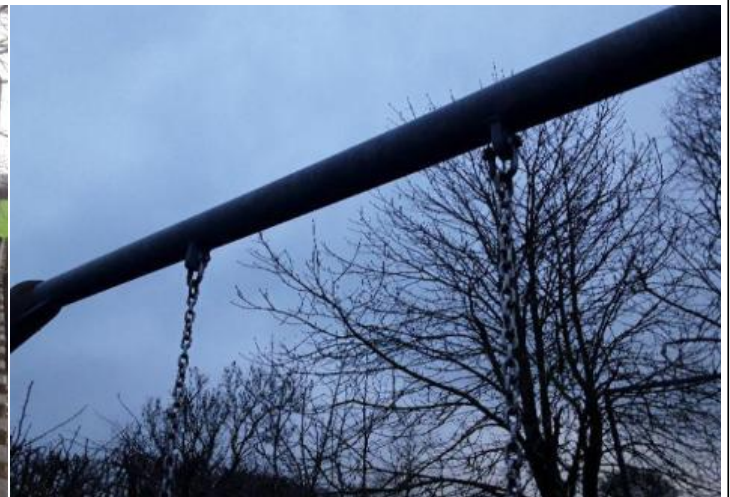
**Finding:** There is some notable evidence of chain wear

**Action:** Monitor for any further deterioration and replace when 40% worn

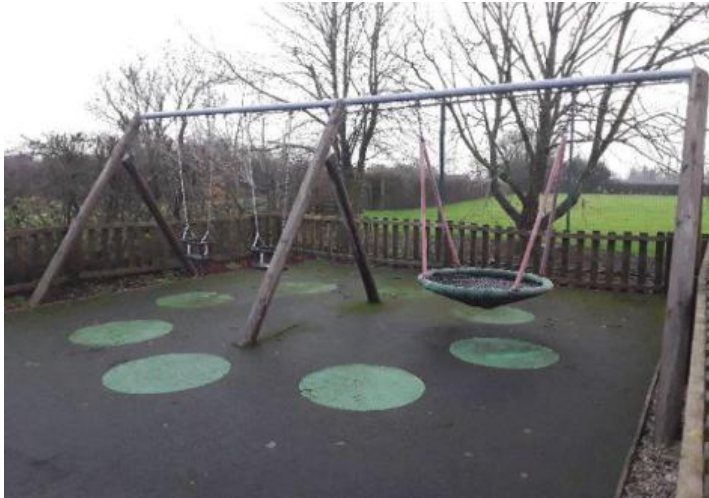
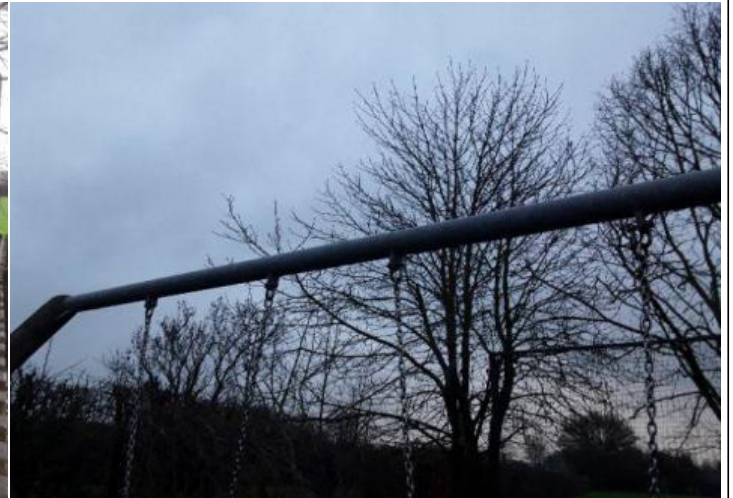
**Finding:** There is some wear to the shackles

**Action:** Monitor for any further deterioration and replace when 40% worn

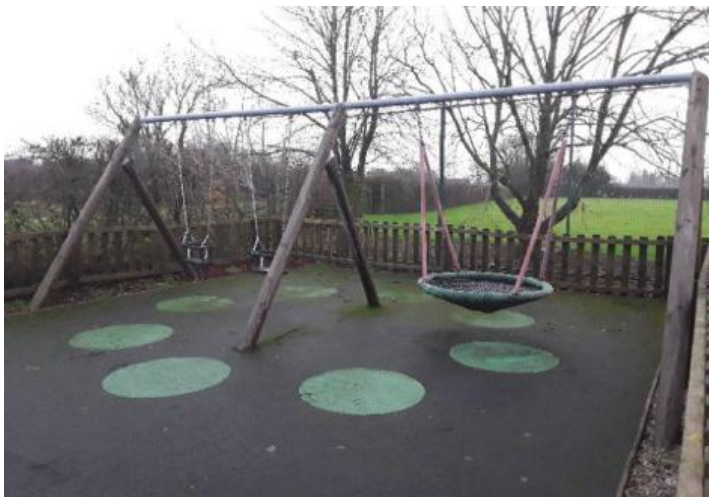
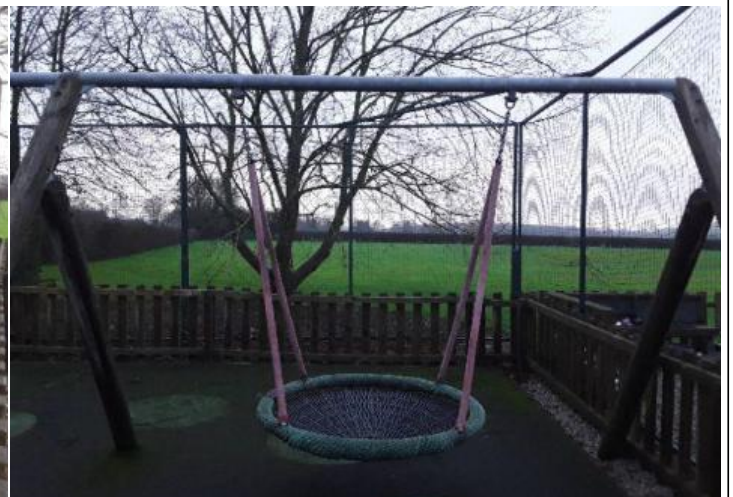
**Finding:** Swings of this design should have a secondary safety mechanism fitted to prevent collapse of the seat in the regularly event of a joint failure to comply with BS EN 1176 Part 2, however this swing was installed prior to the standards being updated in 2018 and the manufacturer has confirmed that the joint was independently cycle tested by BSi

**Action:** Monitor use and check the joint and fixing security
