# the **play inspection** company

## Annual Inspection

Newark & Sherwood District Council

Upton Cricket Club

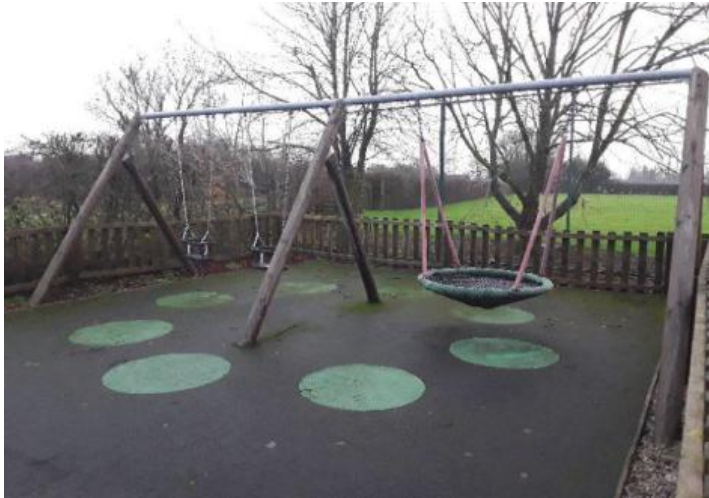
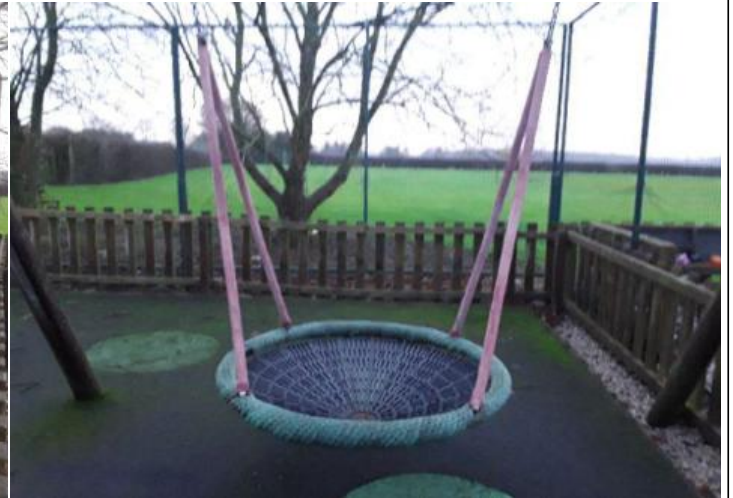
**Finding:** The seat connection cannot be inspected fully as the chain cover cannot be lifted

**Action:** Cut the cover to allow access to the shackle and assess the wear
