the **play inspection** company

Annual Inspection

Upton Cricket Club

Inspection Ref: 2583562

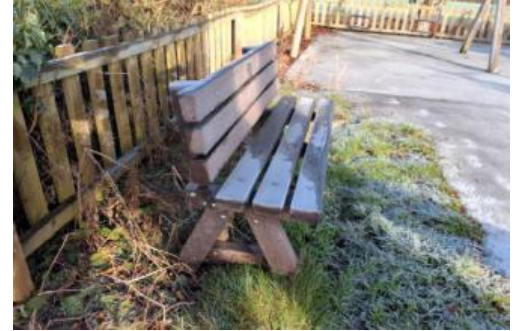
i 4 - Very Low Risk

Item: Bench
Manufacturer: Owner/Operator
Surface Type: Grass
Item Quantity: 1
Equipment Compliance: N/A
Surface Area Compliance: N/A
