# the **play inspection** company

## Annual Inspection

Newark & Sherwood District Council

Upton Cricket Club

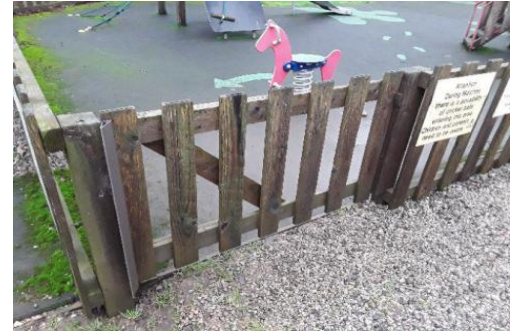
**i** 10 - Low Risk

**Item:** Gate  
**Manufacturer:** Not Identified  
**Surface Type:** Wet Pour  
**Item Quantity:** 2  
**Equipment Compliance:** N/A  
**Surface Area Compliance:** N/A

**Total Findings:** 1

**Finding 1**

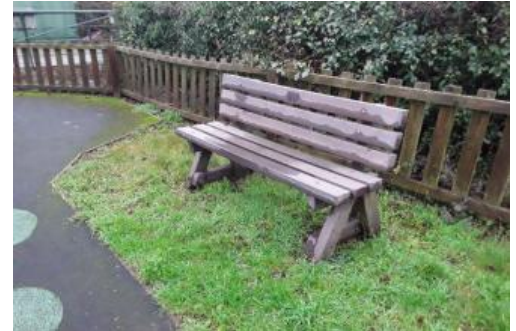
**i** 4 - Very Low Risk

**Item:** Bench  
**Manufacturer:** Not Identified  
**Surface Type:** Grass  
**Item Quantity:** 1  
**Equipment Compliance:** N/A  
**Surface Area Compliance:** N/A

**Total Findings:** 1

**Finding 1**
